Bai Xi Reservoir Spillway Rehabilitation

ABOUT THIS PROJECT:

Market Segment:
Water Holding Structure

Location:
Zhejiang Province,
Ningbo (Ninghai
County), China

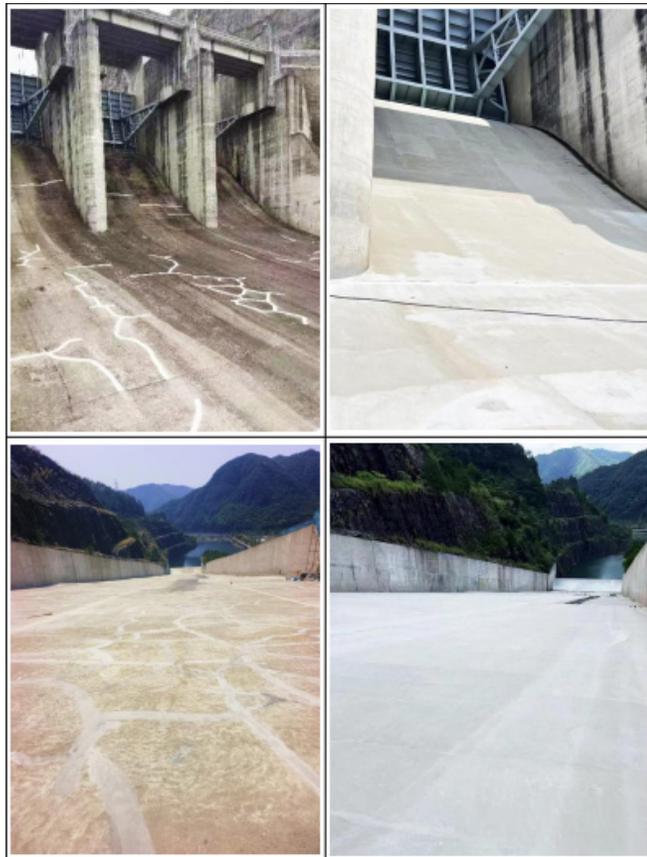
The Bai Xi Reservoir spillway had experienced progressive surface deterioration, cracking, and water infiltration due to long-term exposure to flowing water, weathering, and operational stress. Visible cracking—ranging from fine surface cracks to wider structural cracks exceeding 0.2 mm, raised concerns regarding durability, watertightness, and long-term serviceability of the spillway structure.

Smaller cracks were treated through crystalline penetration, while larger cracks and surface defects were repaired using Xypex Megamix II, providing structural restoration and compatibility with the existing concrete substrate. Following repairs, Xypex Concentrate was applied to the spillway surface to form a permanent, integral waterproofing system capable of resisting ongoing water exposure.

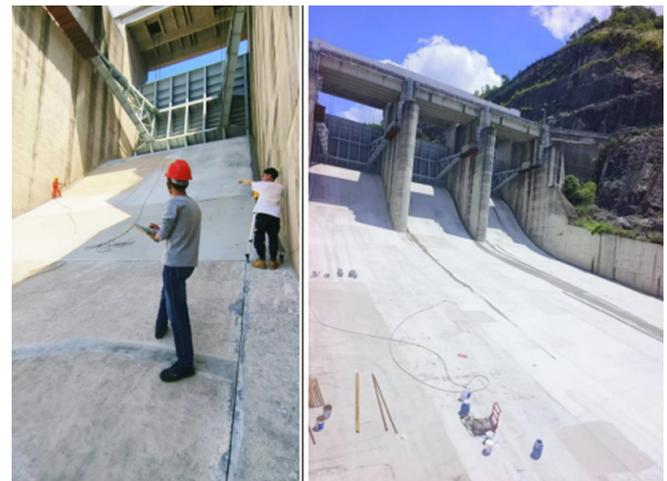
The combined use of Xypex Concentrate and Xypex Megamix II ensured not only effective crack treatment and surface rehabilitation, but also enhanced the concrete’s resistance to water penetration, chemical attack, and future deterioration. As demonstrated by post-repair conditions, the rehabilitated spillway achieved improved watertightness, restored surface integrity, and extended service life, delivering a durable, low-maintenance solution for this critical water infrastructure asset.

To address these challenges, a comprehensive rehabilitation strategy was implemented using Xypex crystalline waterproofing and repair systems. Prior to repair, the concrete surface was thoroughly prepared, and existing cracks were evaluated and treated based on size and severity.
