Pre-Sedimentation Tank Renovation

Market Segment:
Water Treatment Plant

Location:
Eerbeek, The Netherlands

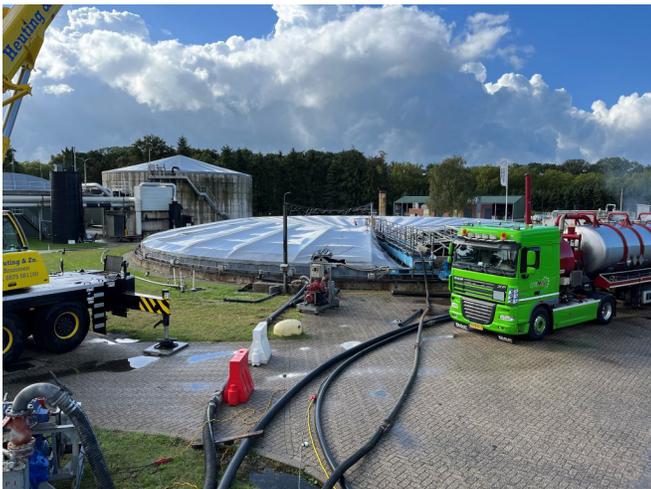
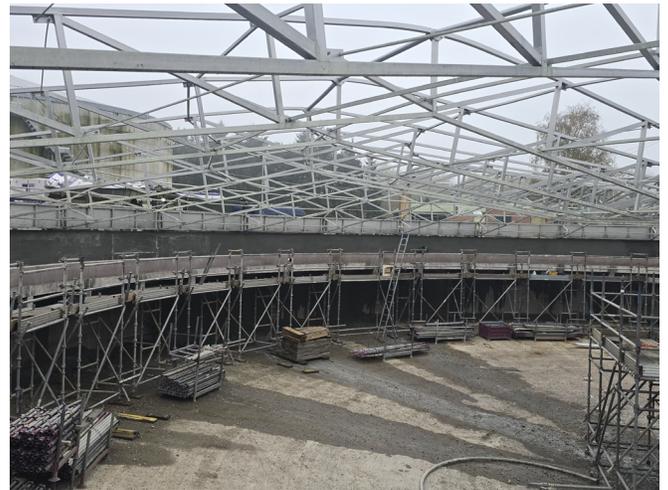
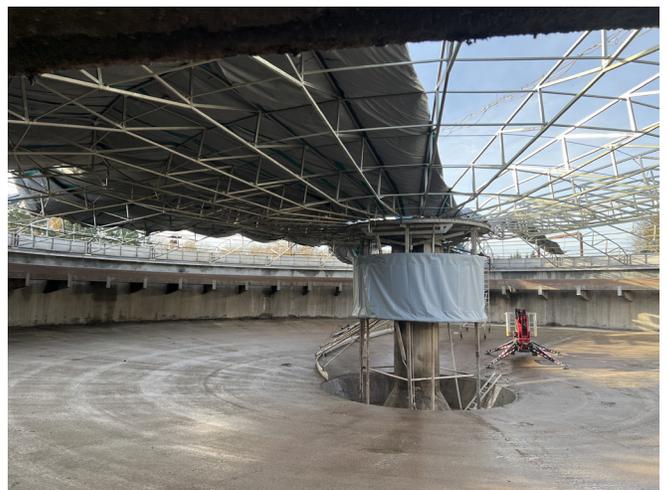
Recently, the situation reached a critical point when the tank, recently covered to comply with odour regulations, suffered severe concrete deterioration due to trapped hydrogen sulphide (H₂S) gas, as well as condensation water, which reached concentrations of 500 ppm.

Within a short period of time after covering the tank, concrete started to deteriorate very quickly and rebar was completely gone at some places. Leaving the tank, that used to be of good quality, heavily damaged.

The damage was mainly to the outer wall, the overflow edge and the center console. The task was to deliver a sustainable, rapid (not only because of the speed of deterioration but also because the tank could not be taken out of operation for a long period of time), and cost-effective repair solution that could be implemented during the wet autumn season, where traditional epoxy coatings would fail to bond.

To address this, the team used ultra-high-pressure (UHD) demolition to remove damaged concrete, then applied a specialized Xypex system. Initially, the plan was to renovate the tankwalls, overflow edge and center console with a shotcrete layer of Megamix II Bio-San.

When on-site inspections revealed deeper structural damage than anticipated, the team quickly adapted by cutting of rebuilding the overflow edge and center console using concrete treated with Xypex Bio-San C500 additive, while the outer walls were renovated using over 11.000 kilo's of Xypex Megamix II with Bio-San, to restore the tank wall to its original thickness and strength. This approach enabled simultaneous preparation and application, significantly reducing the lead time.
