Safeguarding Elevator Pits from Costly Leaks

Market Segment:
General Construction

Location:
Homewood, Illinois

Products Used:
Xypex Concentrate
Xypex Megamix I
Xypex Megamix II
Xypex Gamma Cure
Xypex Patch'n Plug

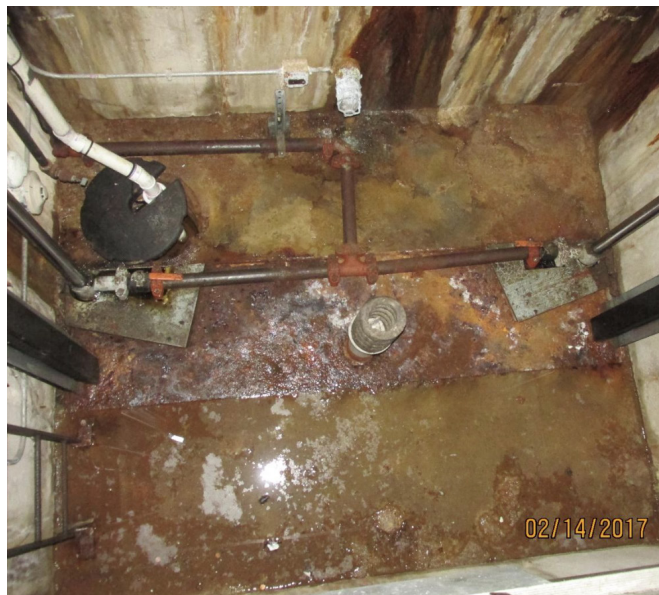
A specific elevator pit located in Homewood, IL, sustained significant damage and exhibited numerous active leaks, thereby jeopardizing the operational integrity of the elevator.

Elevator Pit.

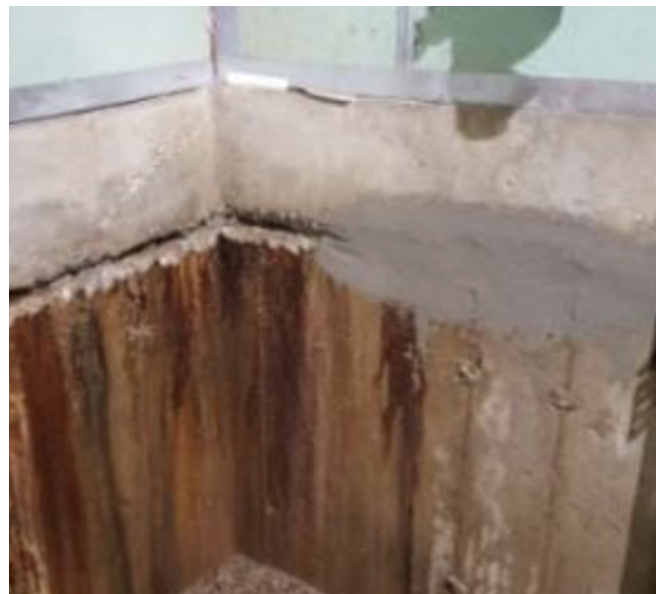
The active leaks, cracks and joints treated with Xypex Patch'n Plug.

The repair process involved power washing the pit walls and floor to remove any laitance and to create an open and porous surface of the severely damaged concrete. To stop the active leaks, the contractor treated the cracks and joints with Xypex Patch'n Plug. Two coats of Xypex Concentrate slurry were then applied to the floor and walls to provide effective waterproofing for the life of the concrete.

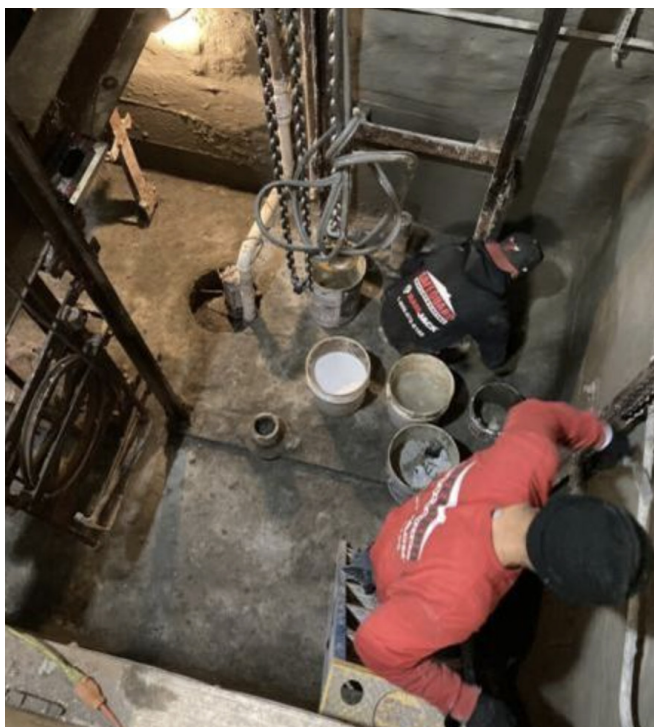
Two coats of Xypex Concentrate slurry were then applied to the floor and walls.

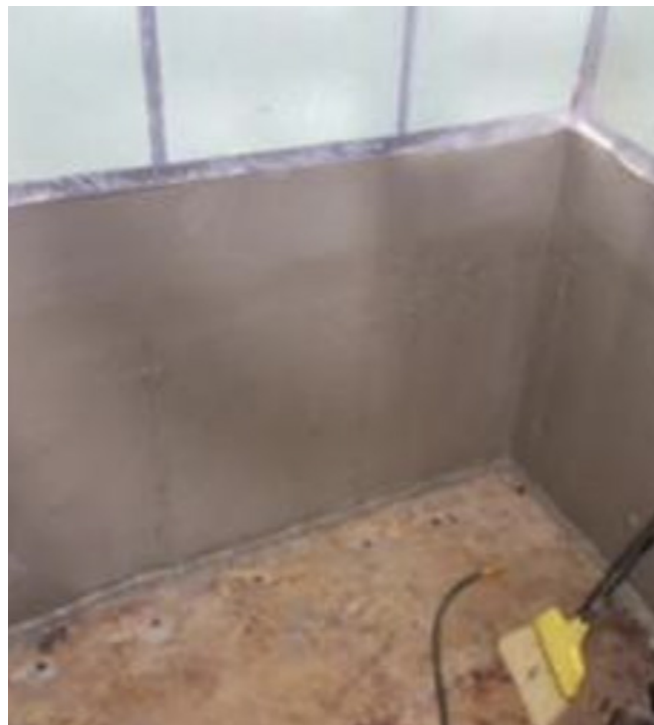
A layer of Xypex Megamix I was applied to the walls for added protection.

A layer of Xypex Megamix I was applied to the walls for added protection and to stop water seepage immediately. For the base of the elevator pit, a half-inch layer of Megamix II was also applied to create a durable, smooth, strong and waterproof floor.

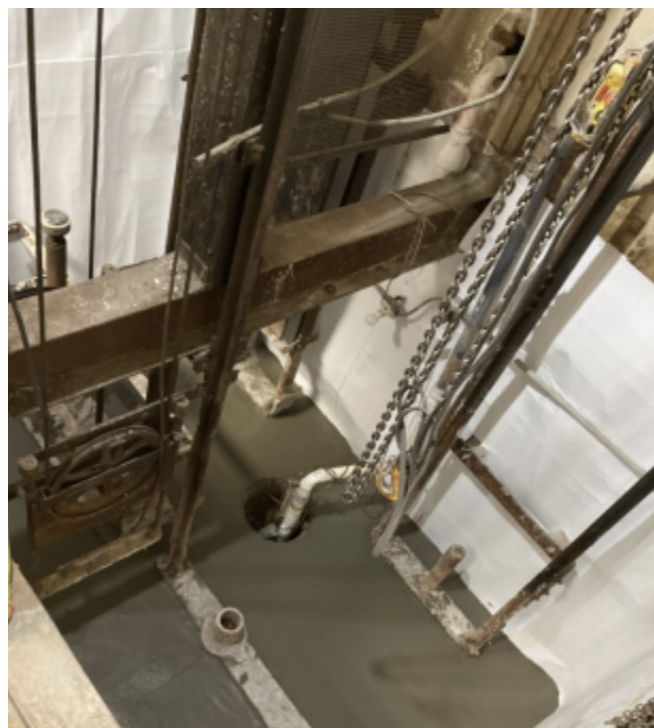
A half-inch layer of Megamix II was also applied to create a durable, smooth, strong and waterproof floor.
