Water Tank Restoration in Cartagena

Market Segment: Water Holding Structures	Consulting and Supervision: CIP SA - Concrete Engineering	Products Used: Xypex Patch'n Plug Xypex Concentrate Xypex Megamix II
Location: Cartagena, Colombia	General Contractor: Empaquetaduras y Empaques

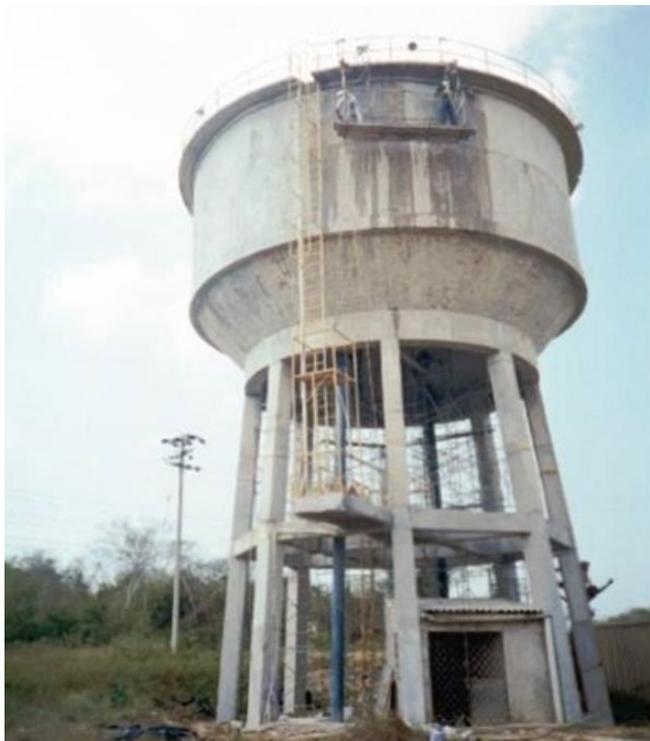
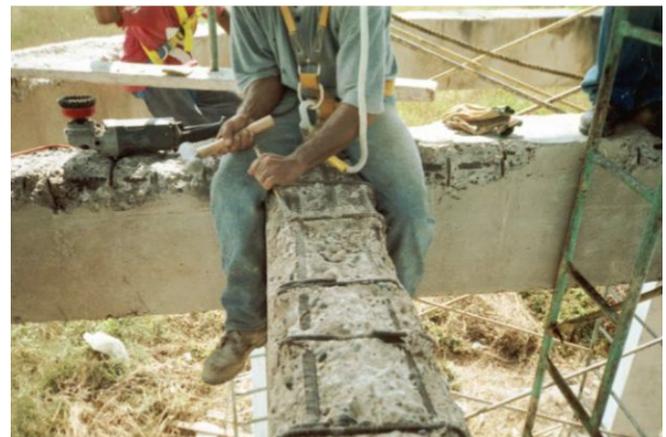
Located in the coastal city of Cartagena, this water tank faced significant challenges due to the city's flat terrain and brackish environment. To ensure proper water distribution across the area, tanks need to be over 10 meters high, but the saline environment and underground water caused severe concrete degradation over time, leading to leaks, corrosion, and water loss.

The elevated chloride presence in the water posed a serious threat to the tank's structural health, severely compromising the concrete and steel reinforcements. A comprehensive restoration was necessary to remove the damaged sections and implement a waterproofing solution that would protect the structure from future damage.

The restoration began by removing the damaged concrete and steel sections, followed by using Xypex Patch'n Plug, a fast-setting hydraulic cement compound, to immediately stop leaks and repair joints and cracks.

Xypex Megamix II was then applied to resurface deteriorated concrete areas, restoring the tank walls and columns. This high-performance repair mortar provides superior bond strength, low shrinkage, improved chemical resistance, and high compressive strength—ideal for demanding applications.

Finally, Xypex Concentrate, a cementitious waterproofing product, was applied as a slurry coat. Known for its effectiveness in both positive and negative side applications, and not requiring a dry surface, Xypex Concentrate penetrates deeply into the concrete, providing permanent, integral protection.

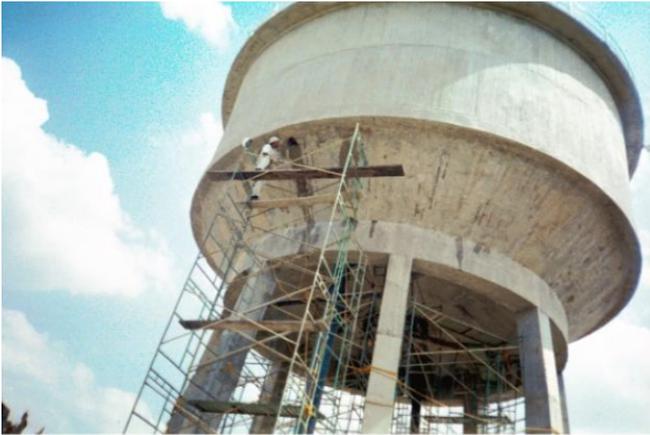
The combination of Xypex Crystalline Technology and careful execution of the restoration has extended the water tank's operational life. It is now resistant to the salty water and the pressures of daily use, ensuring a reliable water supply for Cartagena's residents for years to come.
