Holland Township Community Pool

2022

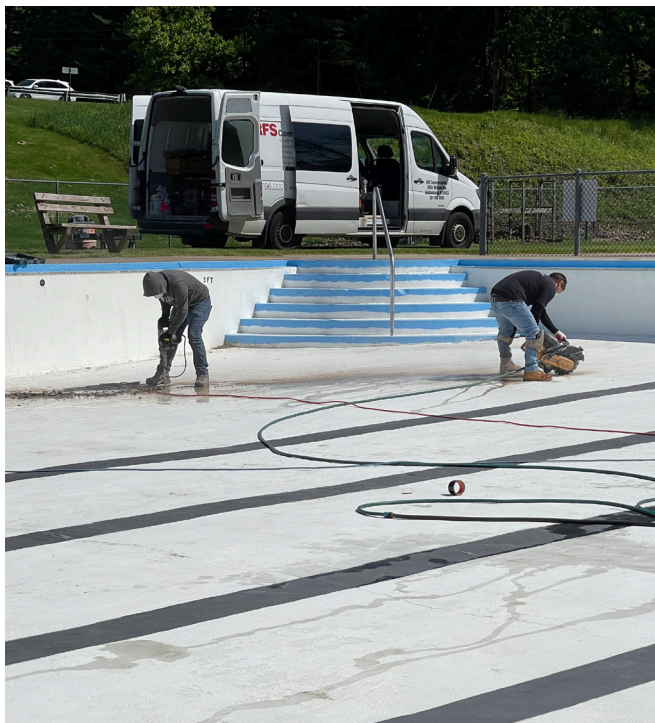
The Holland Township Community Pool in Milford, NJ, has existed since the 1950s. However, deterioration over time has resulted in severe cracks in the concrete. The cracks have compromised the pool's ability to maintain a watertight structure, necessitating annual repairs.

Given the impending start of the pool season, timing was paramount. RFS Commercial, the appointed contractor, strategically opted for Xypex Patch'n Plug, supplemented with Concentrate, to seal the cracks and expedite painting operations swiftly.

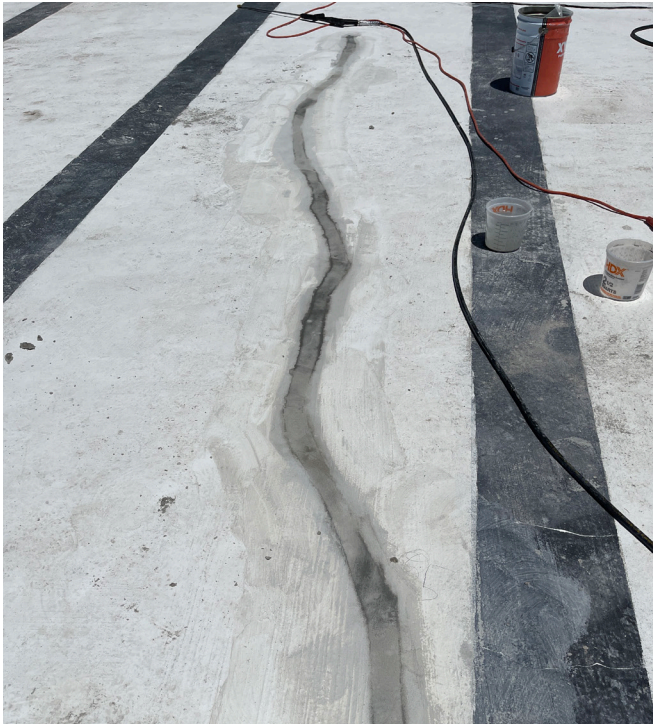
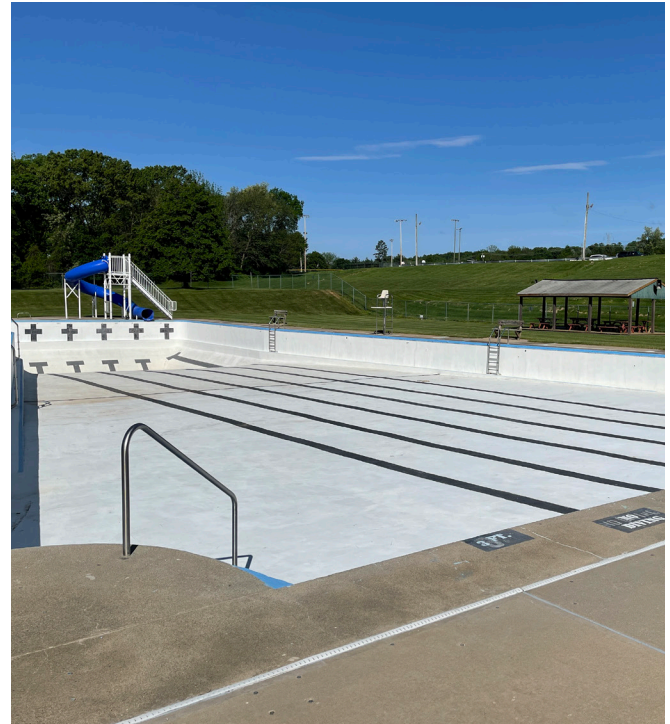
The repair process entailed carefully chasing cracks, followed by the application of Patch'n Plug and then applying Xypex Concentrate complete the restoration. In areas with substantial damage to the walls, Concentrate and Megamix II were both utilized to restore the surface.
