# Yankee Lake Regional Wastewater Treatment Facility

## ABOUT THIS PROJECT:

**Location:**  
Sanford, Florida

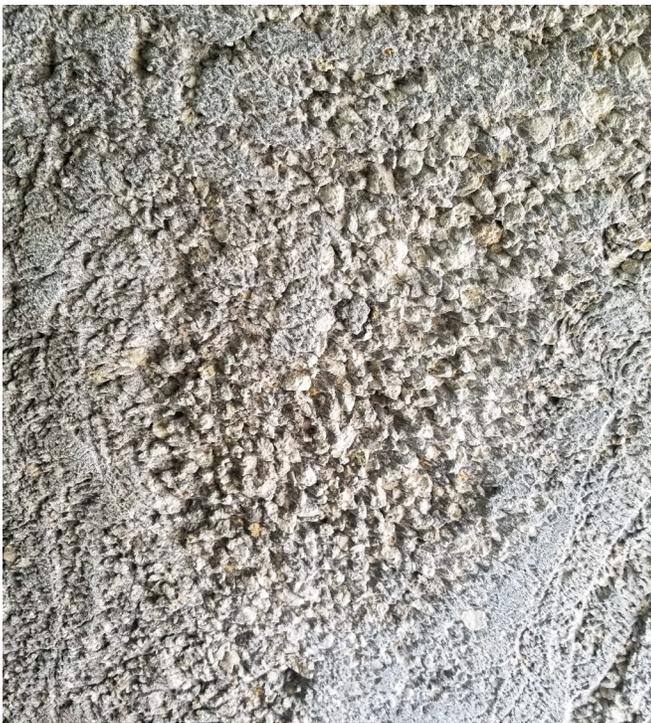
Close-up shot of a deteriorated concrete element

In 2021, after 25 years of operation, many concrete areas suffered serious deterioration as the epoxy coating had previously failed. Sections of the facility such as maintenance holes, the headworks channel and the mud well, were severely deteriorated by Microbial Induced Corrosion (MIC) and contained numerous cracks.

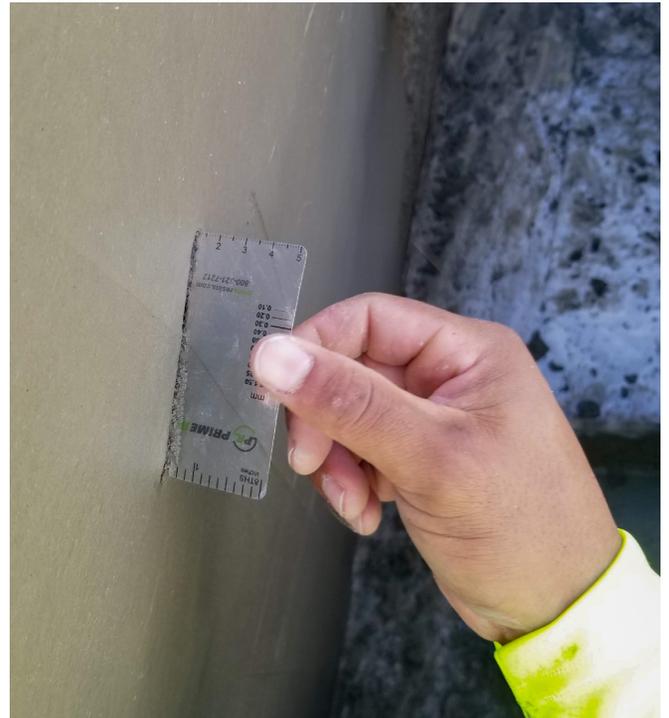
To ensure the correct application and durability of the product in the elements, the thickness of the coating is continuously verified, ensuring its performance in the future.

To start repair works, the general contractor, Crom Corporation, first blasted the old concrete surfaces with a 3,000-psi pressure washer to remove the old epoxy coating, then disinfected the substrate to remove bacteria present on the surface. After these steps, cracks and joints were repaired with Xypex Patch'n Plug and Concentrate.

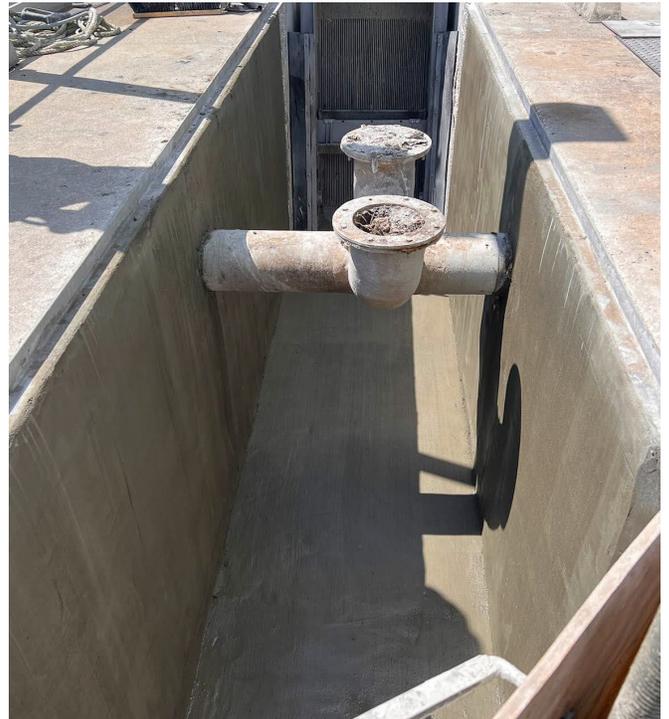
The maintenance pit was repaired with Megamix II with Bio San, thus extending the service life of the concrete structure.

To achieve this, the Crom Corporation team troweled Megamix II with Bio-San to a ½" (13mm) thickness. In some areas, the concrete had deteriorated so much that a thicker repair was required.

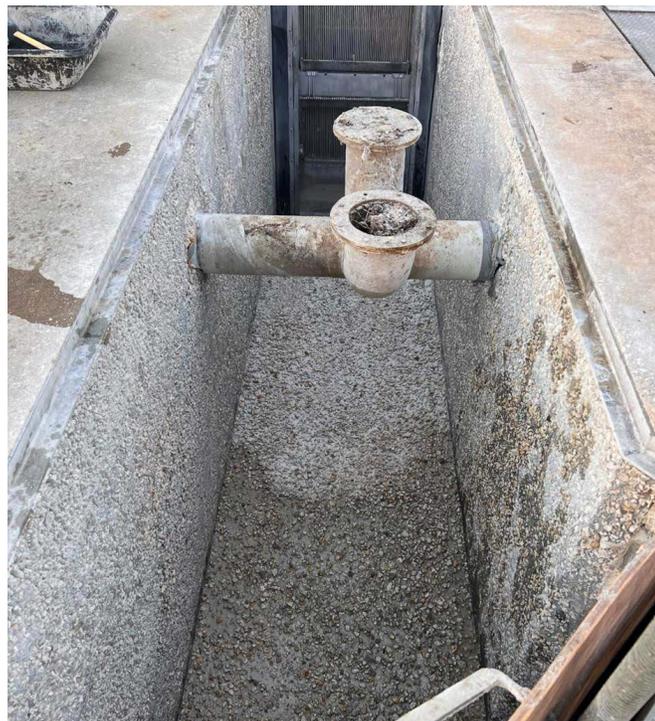
The concrete shows severe damage in the maintenance pits caused by Microbial-Induced Corrosion (MIC), reducing the service life of the structure.

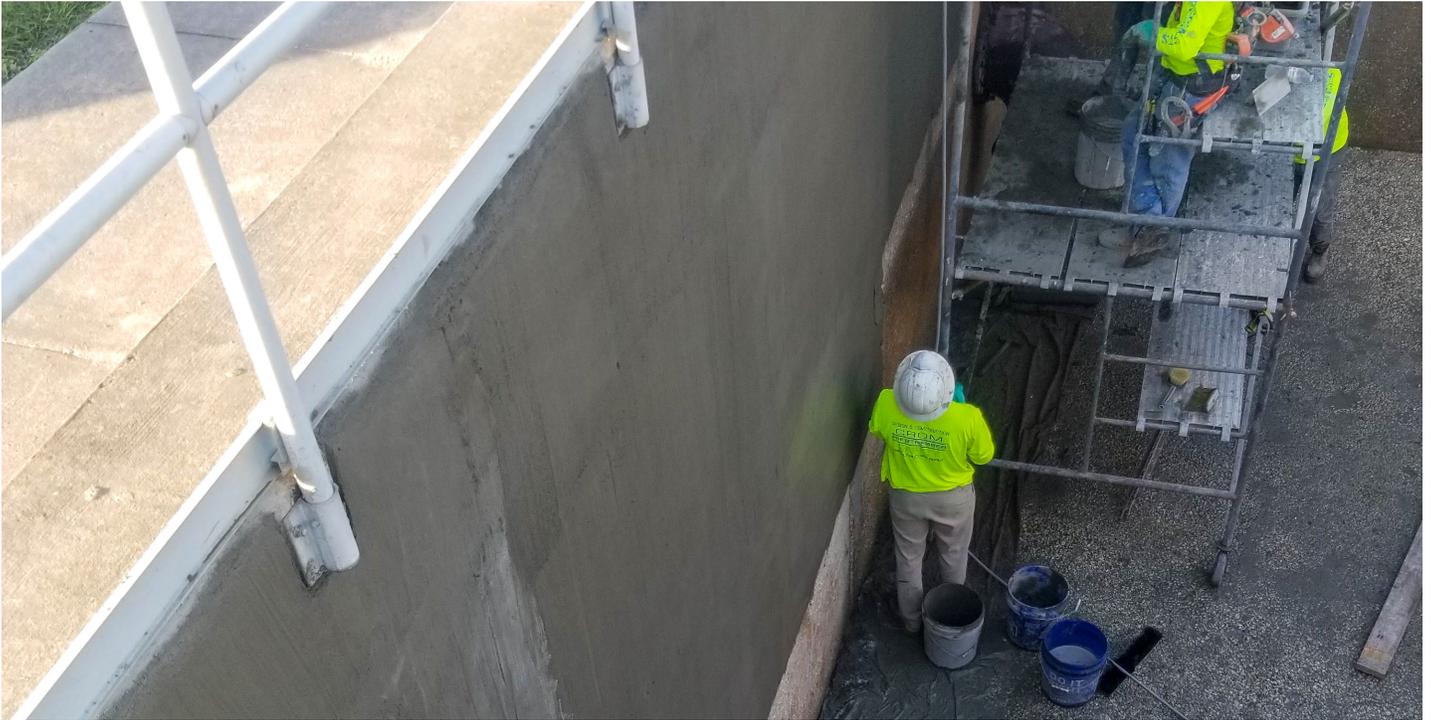
View of the sludge tank undergoing repair with Xypex Megamix II with BioSan.
