## 799 Clifton Road (Home Repair)

Atlanta, Georgia, USA

Products  
**CONCENTRATE,  
MEGAMIX I & II,  
PATCH'N PLUG**

Project Type  
**HOME REPAIR**

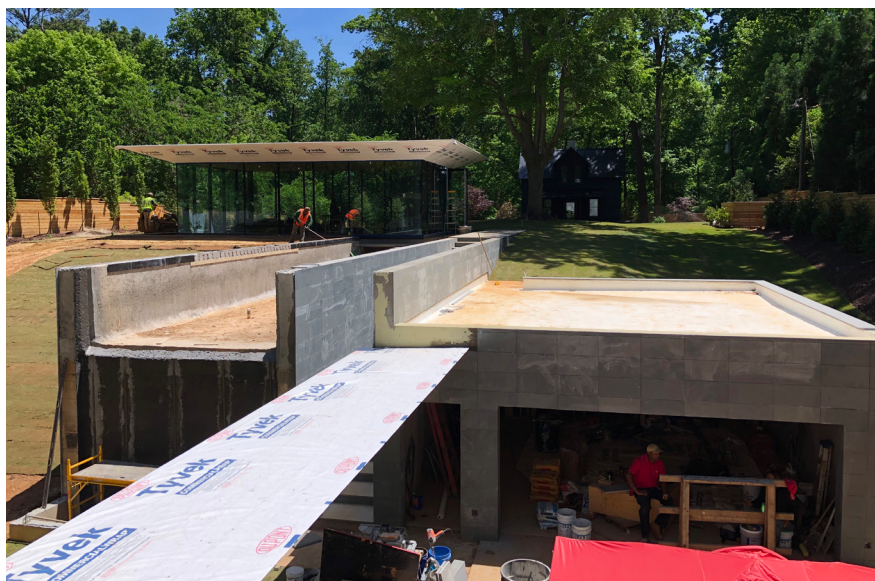
Fig 2 – Pavilion (background), pool and garage addition under construction. [photo courtesy Sheila Lee Davies]

The generous space between the main house and the restored cottage at the rear of the lot provided an opportunity to introduce a modern structure that would complement and enhance the historic site. Davies designed a glass meditation pavilion, featuring a surrounding infinity pool and associated garage (fig 2).

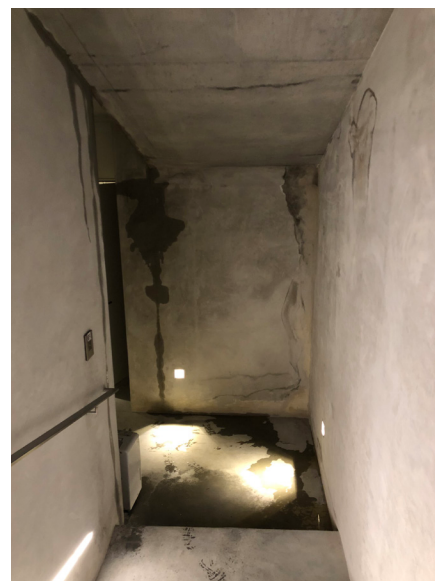
Fig 3 -- **Before:** stubborn water seepage was exacerbated by near record rainfall during construction. [photo courtesy Sheila Lee Davies]

“Water was penetrating from the left and right sides of the tunnel, especially along joints and some cracks,” says Xypex’s Vaughan. “Water was also ponding at the bottom of a set of stairs in the hallway.”

In late 2019, as the project was nearing completion, water seepage was observed inside the underground walkway, which ran from the garage, under the above-ground sidewalk, adjacent to the infinity pool and into the basement of the pavilion (fig 3).

“It wasn’t like there was a single hole in the wall we could point at and fix,” notes Davies. “It was seeping from several locations. We looked at multiple areas where we thought the moisture might be originating. It seemed like we tried everything to stop the leaking—additional drainage and waterproofing—but nothing was working.”

Darby prepared the hallway to receive the Xypex crystalline waterproofing technology. The stucco coating on the hallway was removed to expose the bare concrete surfaces. Tate Waterproofing of Atlanta applied two coats of Xypex Concentrate as a slurry coating by brush to all of the bare concrete surfaces (fig 4).

Xypex Patch'n Plug, a fast-setting hydraulic cement for concrete patching and repair, was used to fill all wall/ceiling and wall/floor joints. Patch'n Plug provides the same crystalline technology as other Xypex products. Xypex Megamix I & II were also used to fill any voids found in the concrete. Megamix is a repair mortar based on Xypex Crystalline Technology.
