## Chehe River Mine

Guangxi, China

Owner  
**GUANXI HUAXIA GROUP**

Products  
**CONCENTRATE,  
PATCH'N PLUG**

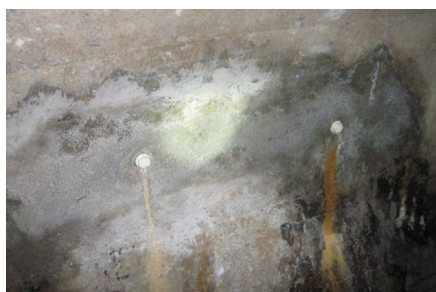
*Previous leak repair*

The mine tailing overflow pipes of this mine are buried at 60 m to 80 m underground, 1.8 m in diameter and sloped to a 45° angle. Officially commissioned in 1980s, the joints of the pipes had been leaking for many years due to increased load. Additionally, the concrete of the pipes had suffered severe corrosion and spalling due to acidic attack. In many areas the reinforcing steel of the concrete was exposed. Previously, these pipes had been repaired on an annual basis as the materials used for the repair could not withstand the water pressure or acid attack.

Xypex products were chosen to rehabilitate these pipes as they resist hydrostatic pressure, chemical attack and are a permanent solution thus avoiding future maintenance intervals and shutdowns. Additionally, they are used on wet concrete so removing the need to dry out the concrete before application. Xypex [Patch'n Plug](#) was used to seal active leaks in the pipe joints and Xypex [Concentrate](#) was used to provide waterproofing and acid resistance to the pipe sections.

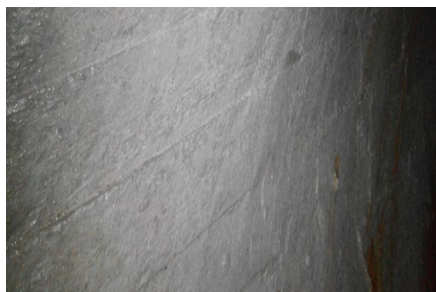
*After Xypex repair*

The pipe was inspected 6 months after application and found to be in an excellent condition. As a result, the asset owners chose to rehabilitate other structures using [Xypex Crystalline Technology](#).
