Wastewater Tunnel Repair

Hemer, Germany

Contractor / Applicator
BAWAX GmbH

Products Used
**PATCH'N PLUG,
CONCENTRATE**

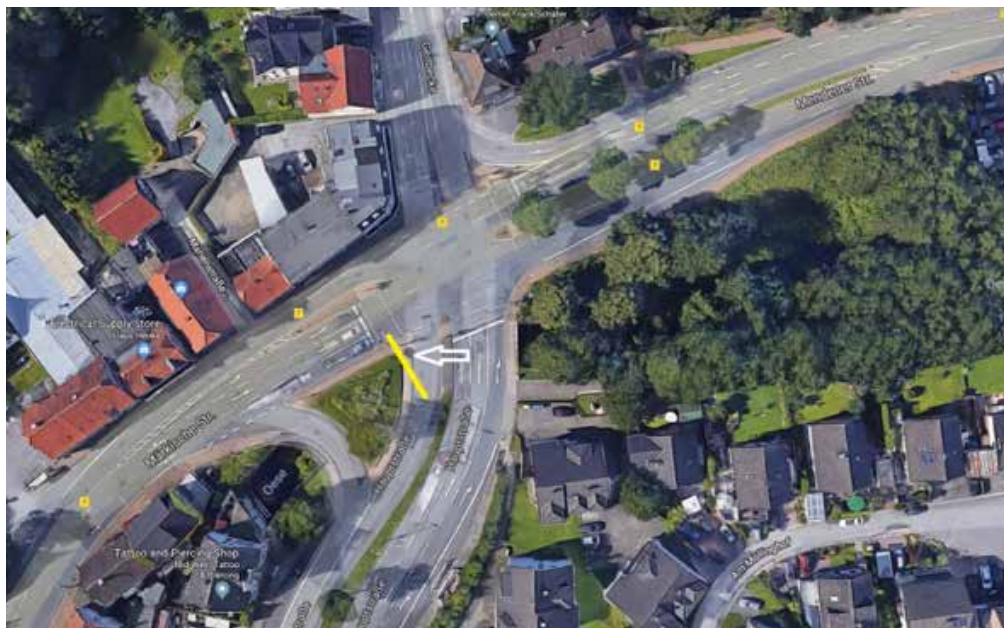
The leaking culvert is indicated by the arrow and yellow line on the aerial photo above. The culvert is located about 14 meters below ground and below the Oese River. About 30,000 vehicles per day pass through this major intersection in the city of Hemer. Complete replacement of the culvert was ruled out due to the extensive traffic disruption this would have caused, as well as a cost of approximately €400,000.

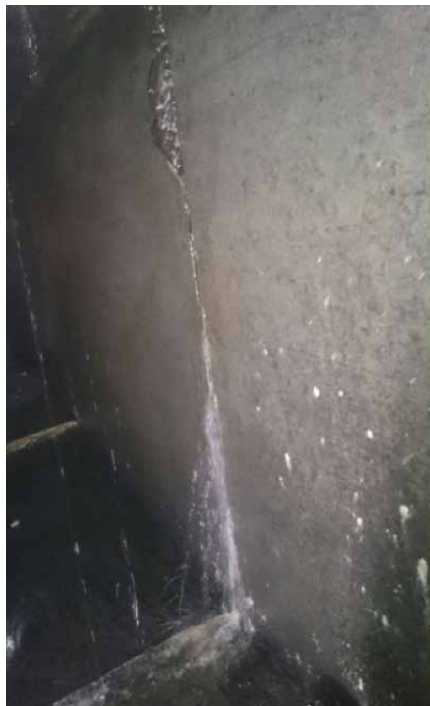
In 2014, the Hemer department of waste water, as part of a routine inspection by remote camera, discovered that a large amount of water was leaking into the precast box culvert, known as a *Düker* in German. Each of the culvert's 16 precast segments were leaking profusely as a result of deteriorated seals and constant hydrostatic pressure imposed by the river flowing just above.

Every joint between segments of the precast box culvert was leaking prior to the repair project. It is estimated that more than 1.7 million liters per day was leaking into the culvert from the Oese River, which flowed just above the structure.

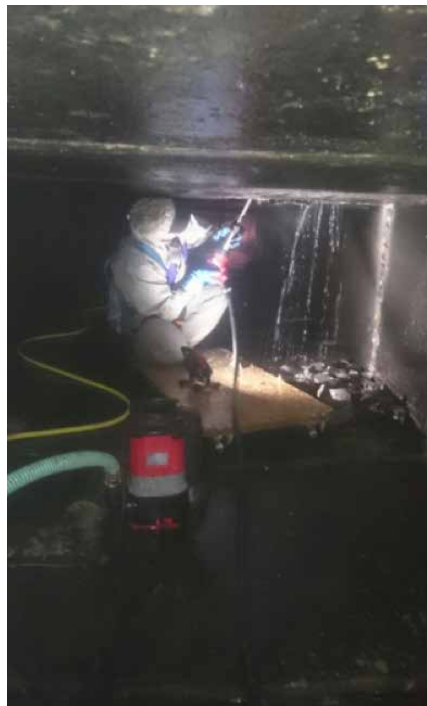
The Bawax applicator cleans an overhead joint between precast segments of the box culvert to provide a clean space for the application of Xypex Patch'n Plug.

out water and blow in fresh air,” Schaefer explains. The culvert had to be cleaned of dirt and debris and pressure washed to provide a clean joints and surfaces.

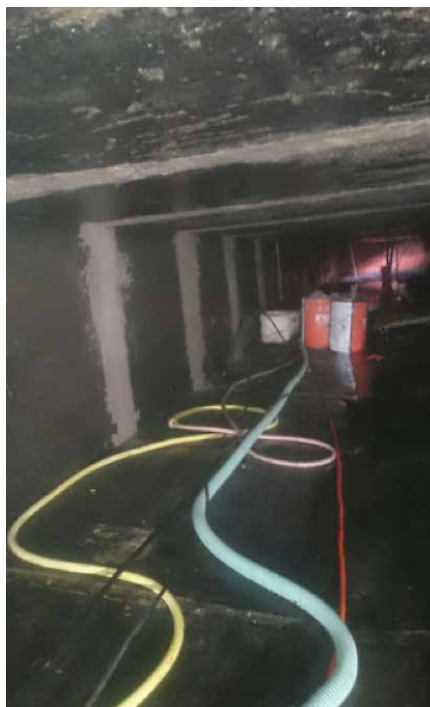
Xypex Patch'n Plug was applied to 102 meters of leaking cracks and joints between segments of the precast box culvert. Here, as the Bawax applicator completes the first phase of the project, most leakage has been halted.

The first phase of the project required the Bawax applicator to fill in all of the joints between the precast culvert sections with Xypex Patch’n Plug fast-setting hydraulic cement compound. Patch’n Plug stops flowing water in seconds and is used to seal cracks and other holes or defects.

For particularly large cracks, primarily along the bottom of the culvert, the applicator used a rubber gasket strip pushed deep into the crack to reduce the water flow, thereby enabling him to fill the gap completely with Patch’n Plug. Xypex crystalline waterproofing technology is cement based so it permanently bonds to concrete and masonry. The active chemicals in the product diffuse into the substrate and react with moisture and the constituents of hardened concrete to generate a non-soluble crystalline formation that prevents the penetration of water from any direction.

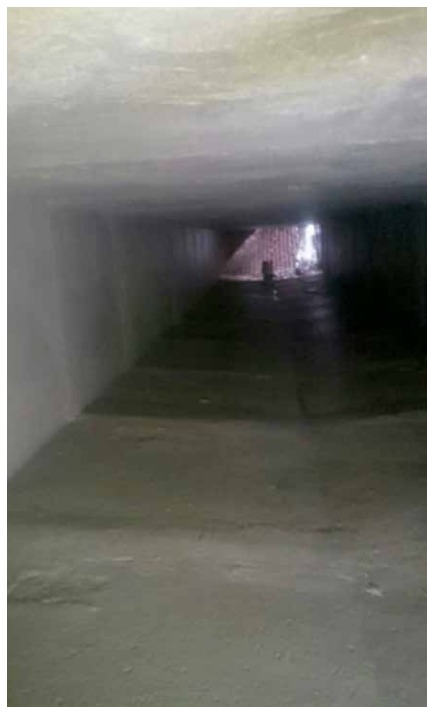
Culvert coated with Xypex Concentrate crystalline waterproofing.

Once the 102 meters (335 feet) of leaking joints were sealed, the applicator then coated the entire interior (approximately 96 m²) of the culvert with Xypex Concentrate, which is a cementitious slurry consisting of Portland cement, finely graded sand and active proprietary chemicals. Xypex Concentrate, like Patch’n Plug, prevents the penetration of water and other liquids from any direction and can seal hairline cracks in concrete of up to 0.4 mm.
