Chishi Bridge

Yizhang County, China

Completion Date
2016

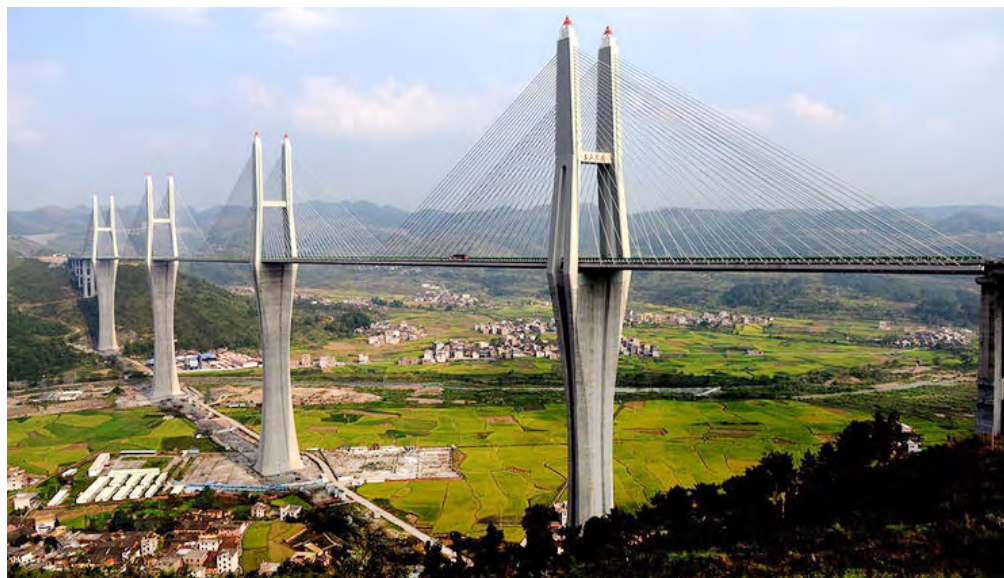
The location of the fire – within the hollow Pylon P6(S)

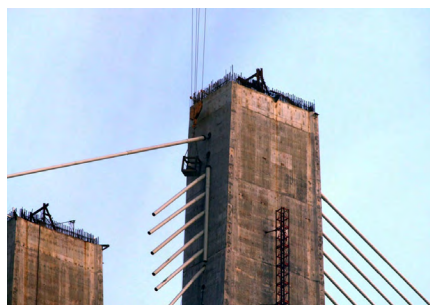
Nine of the twenty three cables supporting the bridge girder on the western side of Pylon P6 (S) broke as a result of the fire occurring inside the hollow pylon.

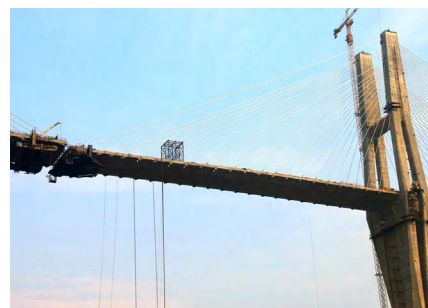
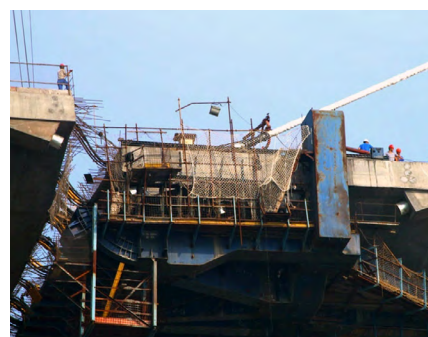
As the support cables broke, the cantilever end of the girder dropped by over 2.0 m on the south side, 0.8 m on the north side, with the twisting motion resulting in significant cracking of the girder and the bridge deck above it.

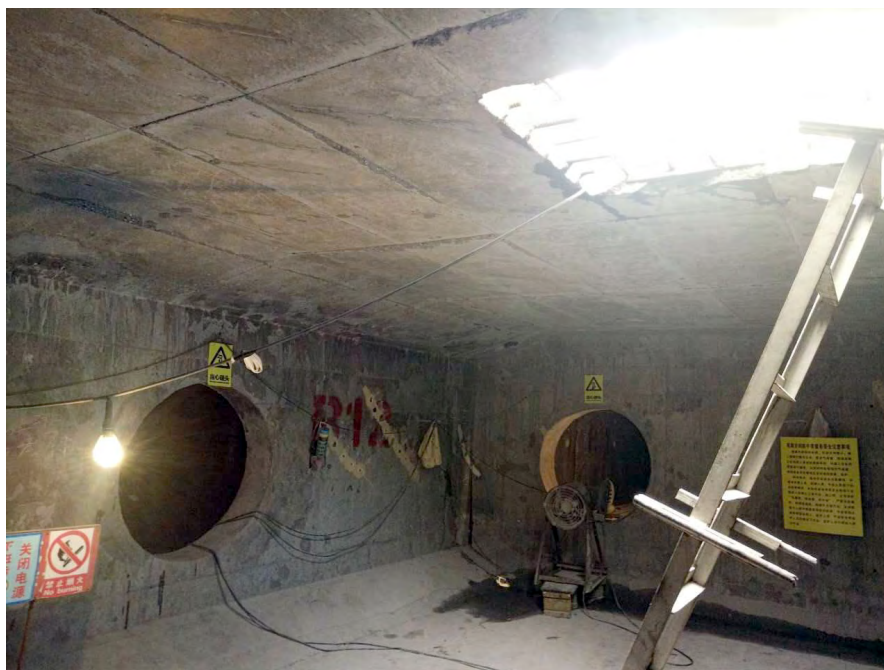
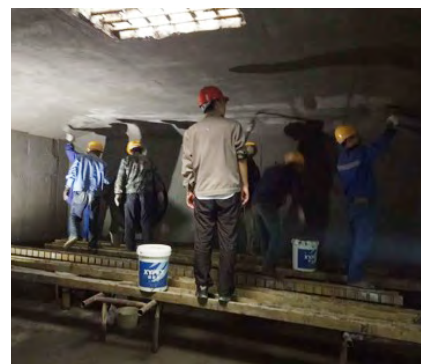
Almost 10,000 square meters of crack sealing and durability enhancing Xypex Concentrate treatment were applied at the direction of engineers of the Chishi Bridge recovery team.

Xypex applications thus began in April of 2016, with Xypex Concentrate being applied within the interior of the affected box girder, areas of the bridge deck, Pylon P6 and various related concrete components. Through strict process management and control during the treatment of approximately 10,000 square meters of internal and external surfaces, the application of Xypex proved a complete success, ensuring the 'healing' of a residual of cracks as well as the restoration of integrity and durability throughout the stress-impacted concretes.

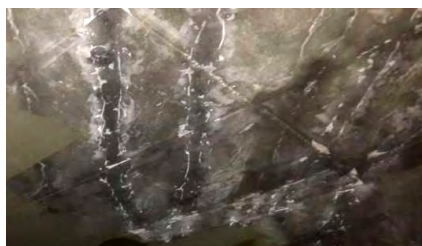
The failure of nine support cables as a result of the fire resulted in a dense distribution of diagonal cracks in the box girder and the top slab.
