# San Diego International Airport Northside Capture Reuse Cistern

San Diego, California, USA

Project Type  
**INDUSTRIAL WATER  
CONTAINMENT - AIRPORT**

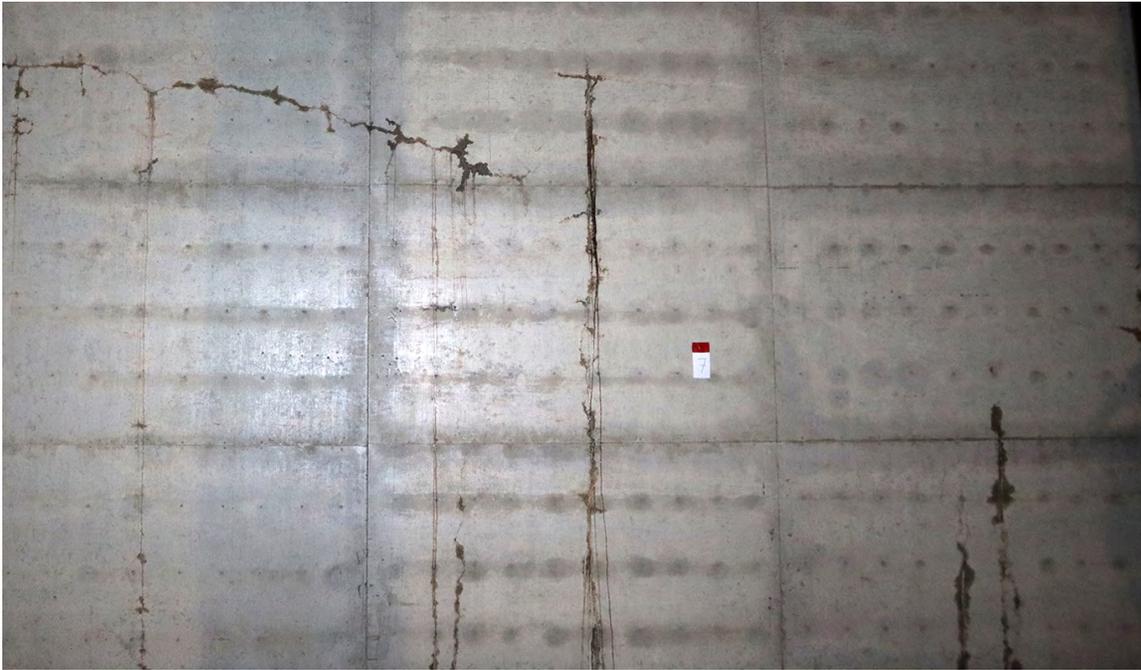
*Concrete liner wall section after pumps decommissioned and watertable had recharged – water leaking through cracks.*

The use of 8000 - 9000 cubic yards of Xypex Admix treated concrete in this 13,000 cubic yard project created a fully waterproof structure. Water table conditions are such that the bottom of this 30' deep cistern is under a water pressure of 16' of head. Images captured during the construction phase (see next page) showed water leaking through the inevitable cracks in the concrete liner with

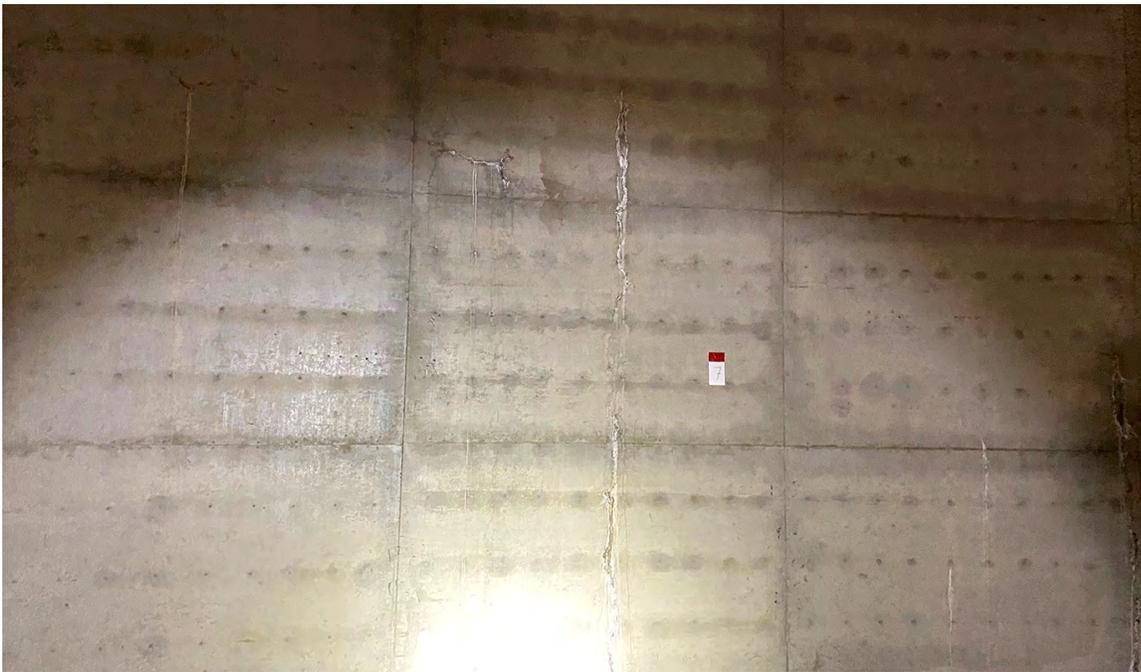
*Same point on wall 7 weeks later – cracks fully healed with no water leakage against constant hydrostatic pressure.*

Xypex crystal development evident as the cracks self-healed. The photo of the finished cistern shows the fully healed and non-leaking walls of the cistern.
