Largo Wastewater Treatment Plant

Florida, USA

Products
MEGAMIX II WITH BIO-SAN, CONCENTRATE

Project Type
WASTEWATER TREATMENT IMPROVEMENT

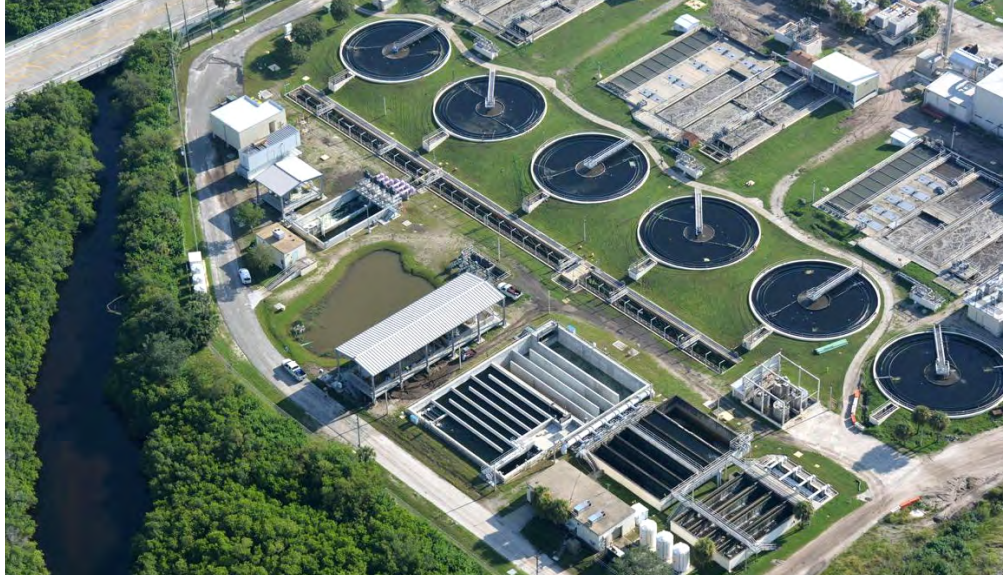
Fig 1 -- Xypex Megamix II with Bio-San was used to repair and protect critical Biological Nutrient Removal (BNR) systems at the Largo Wastewater Treatment Plant (WWTP) located in Largo, Florida, USA.

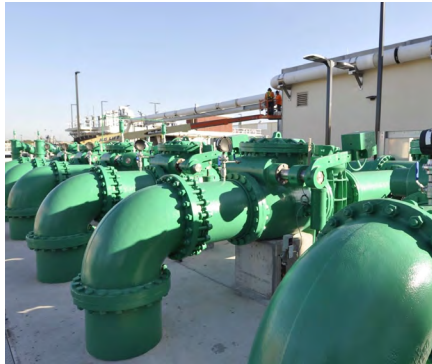
Fig 4 -- New influent pumping station installed at the Largo WWTP, along with a 5 million gallon equalization tank, is capable of holding the storm surge flows experienced during hurricanes and other extreme weather events.

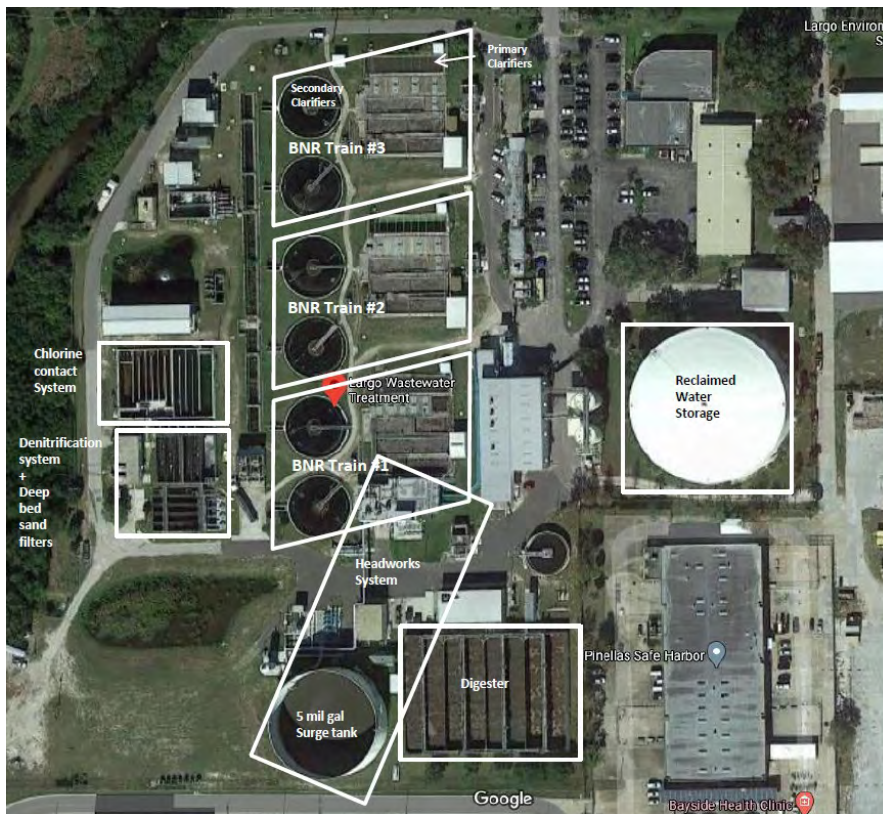
Each five-chamber BNR train is coupled with two large circular secondary clarifiers (fig 5) that are positioned down the center of the plant, directly adjacent to the BNR trains. The concrete BNR trains were in need of the highest level of restoration, having been exposed to physical and chemical attack throughout 50 years of service.

Fig 5 -- The city of Largo, Florida, has invested more than \$60 million in recent years to upgrade its primary WWTP. Xypex Megamix II with Bio-San and Xypex Concentrate were used to restore the three biological nutrient removal (BNR) “trains” at the plant.

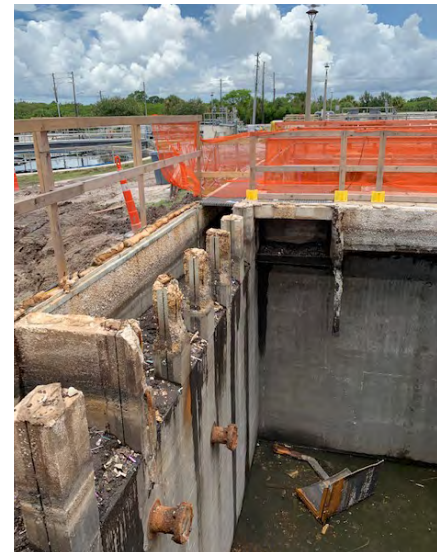
Damage to the BNR trains and associated clarifiers (fig 6) ranged from concrete tanks with large cracks and exposed aggregate to structures with less severe deterioration and only minor cracking. Many solutions were suggested, but the decision came down to two candidates:

Fig 6 -- Xypex Megamix II with Bio-San repair mortar and Xypex Concentrate crystalline concrete waterproofing and repair treatment were used to restore many years of concrete deterioration at the Largo Wastewater Treatment Plant. Megamix saved time by allowing the repair and long-term protection of damaged concrete in one step.

For BNR tanks and secondary clarifiers with only minor cracking or other superficial damage, Exceletech applied Xypex [Concentrate](#), a crystalline waterproofing and protective coating. Like Megamix II with Bio-San, Xypex Concentrate diffuses into the concrete substrate and reacts with water and the by-products of cement hydration causing a catalytic reaction.

This reaction generates a non-soluble crystalline formation throughout the pores and capillary tracts of the concrete. Xypex Concentrate has been shown in the laboratory to penetrate to a depth of up to 12 inches and can seal cracks up to 0.4 mm. Both Concentrate and Megamix II permanently seal concrete, preventing the penetration of water and other liquids from any direction, even under high hydrostatic pressure.

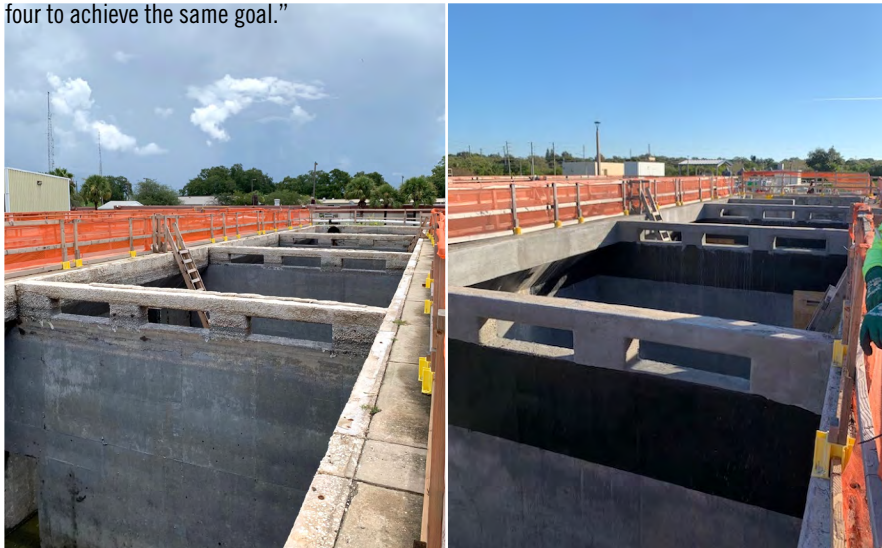
Fig 7 -- **LEFT:** Here, one of the 25 ft x 100 ft multi-compartment BNR channels is undergoing rehabilitation using Xypex Megamix II with Bio-San repair mortar to rebuild severely deteriorated concrete. **RIGHT:** shows BNR channel after restoration with Xypex Megamix II with Bio-San. Black strip is a layer of coal tar epoxy applied as added protection in H₂S gas hot zone.

Exceletech Coatings and Applications of Clermont, Florida, was selected to repair the Largo WWTP BNR infrastructure. The firm prepared the concrete tanks by pressure washing the damaged walls to remove loose concrete and other debris.

Large cracks were power-chiseled to create a space to accept a dry-pack of Megamix II with Bio-San, which was then covered with a top coat of Megamix II with Bio-San. The Xypex repair mortar can be applied via sprayer or trowel

at a thickness of 3/8 to 2 inches. It must be applied to a surface in saturated surface dry (SSD) condition (fig 7).
