# City of Fargo Wastewater Collection & Treatment

ABOUT THIS PROJECT:		
<b>Market Segment:</b> General Construction, Marine Structures	<b>Owner / Developer:</b> City of Fargo	<b>Products Used:</b> Xypex Bio-San
<b>Location:</b> Fargo, North Dakota, USA	<b>Ready-Mix:</b> Rinker Plant, Hawley MN

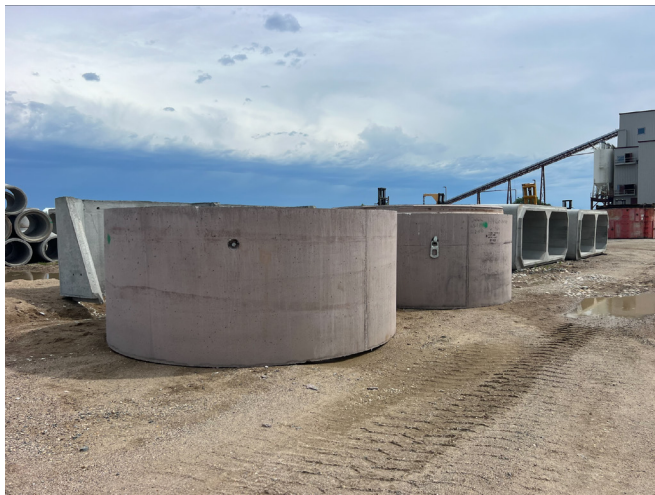
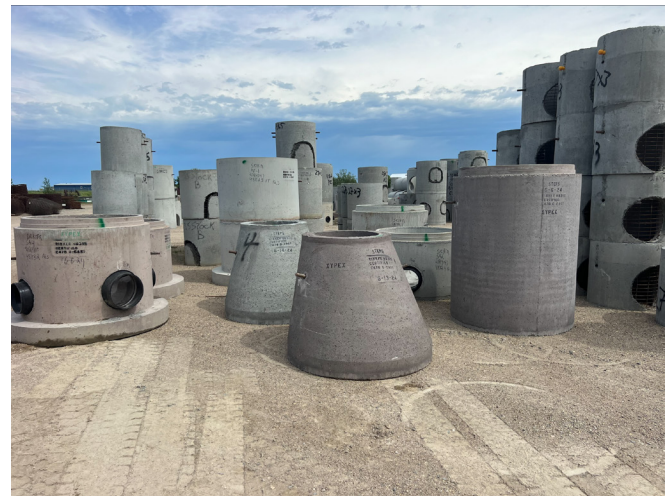
An added benefit of using Bio-San is its distinctive brown tint. This visual marker made it easy for officials to identify Bio-San-infused concrete on-site, significantly simplifying the field verification process. Project Manager Jason Satterlund (City of Fargo) noted the color difference when Bio-San-treated products were removed from the truck and placed in front of the non-Bio-San-treated structures, as seen in the images. This visible color contrast made it easier for inspectors, to confirm that the correct additives were used. It served as a simple yet effective quality control tool, providing confidence in the materials used throughout the project. Overall, Bio-San contributed significantly to the project's success, providing both durability and ease of verification throughout the installation process.

The City of Fargo's sewer extension project involved the installation of 1 wet well, 6 units of 6-foot diameter manholes, and over 14 components of sewer lines and lift stations. Bio-San was specified for the project to protect the concrete from MIC (Microbial-Induced Corrosion), harmful chemicals, and water penetration. Approximately **80 cubic yards of Bio-San** was used, with the precast structures produced at **Rinker's Plant in Hawley**.
