# Jiangbei Bridge Concrete Rehabilitation

2023

**Products Used:**  
Xypex Concentrate

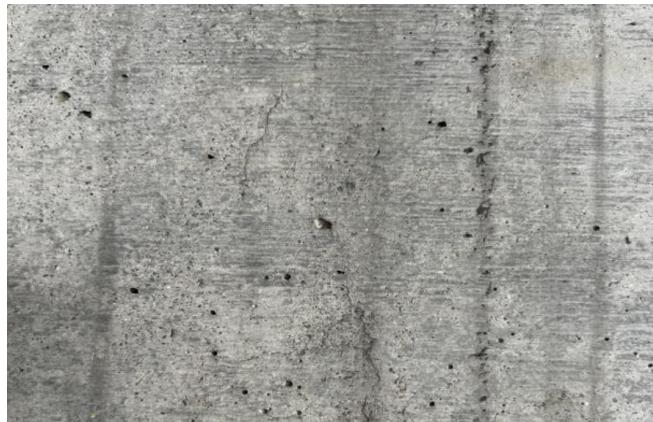
During routine maintenance, irregular fine cracks were found in the prestressed T-beams of the northern approach section. Due to the bridge's age, localized concrete reinforcement exposure and rust expansion were also observed.

Although these issues do not immediately affect structural safety or normal traffic operation, they deteriorate the durability and appearance of the bridge, thereby shortening its service life.

Considering that Jiangbei Bridge has been in service for a long period, and in order to enhance the durability of the prestressed T-beam concrete and extend its service life, it was decided to use the XYPEX Concentrate crystalline slurry coating system for surface rehabilitation and strengthening.

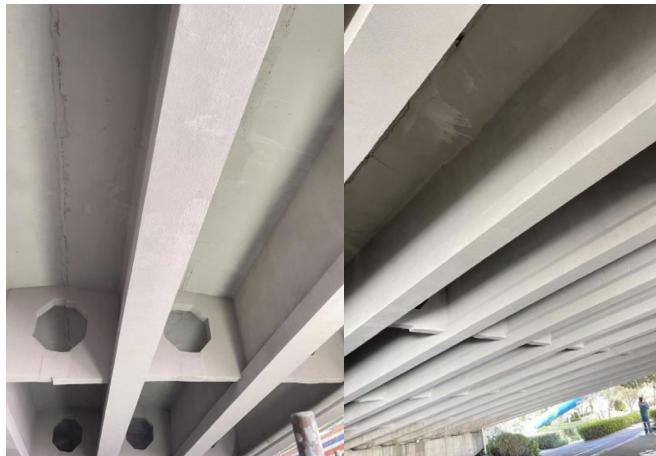
Using water as a carrier, these chemicals penetrate into the concrete and react with tricalcium silicate and calcium hydroxide in the cement paste to form insoluble, dendritic calcium silicate hydrates (C-S-H) and calcium aluminate hydrates within the capillary pores.

These crystalline formations integrate permanently with the concrete matrix, effectively blocking water and other liquids from any direction, thus providing permanent waterproofing, anti-corrosion protection, and reinforcement of the concrete structure.
