The Sorek delamination plant in Israel was at the time the largest desalination plant in Israel.

This plant takes water from the Mediterranean Sea, removes the salt to create fresh, potable water and ejects the high salt brine back to the sea. The water feed lines (2 separate pipes) and the brine ejection line (one single pipe) combine for a total combined pipe length of approximately 9.7 km. The pipe sections are thick walled pre-cast pieces that were "pipe-jacked" from a launch site on land through an excavated tunnel under the sea bed.

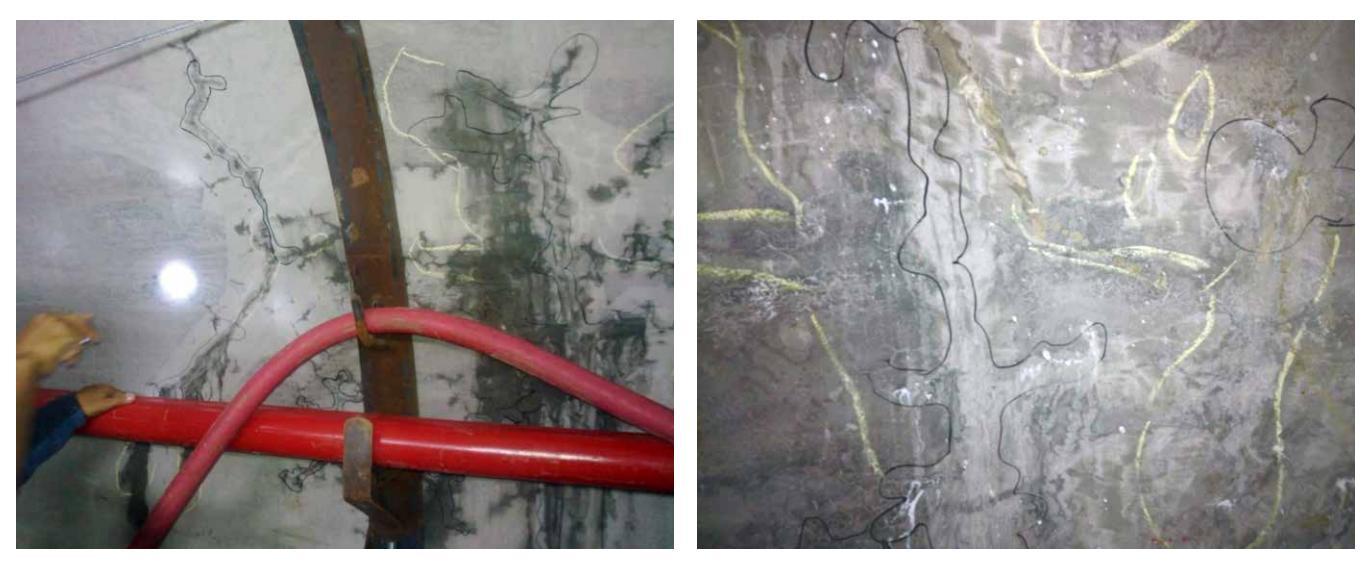
*November 2011 – Weeping Cracks*

March 2012 – Cracks Healed

After thorough investigation, the project design team chose to include 1.5% of Xypex C-500 NF Admixture in the concrete mix to both heal cracks as well as improve the overall chloride durability of the pipe. As the pipe was jacked into place visible leaking was seen in the pipe sections. All visible leakage was seen to heal and the project became so impressed with Xypex's crack healing ability that the use of the Xypex Admix was extended in the project to include most of the water processing and holding structures as well as the pipe. The project used over 300 tonnes of Xypex C-500 NF Admixture as well as Xypex Concentrate and Xypex Patch'n Plug for joints and other works. Xypex is proud to have been a part of this highly successful project.
