Mitchell Water Treatment Plant

Greensboro, North Carolina, USA

Project Type STRUCTURAL REHABILITATION

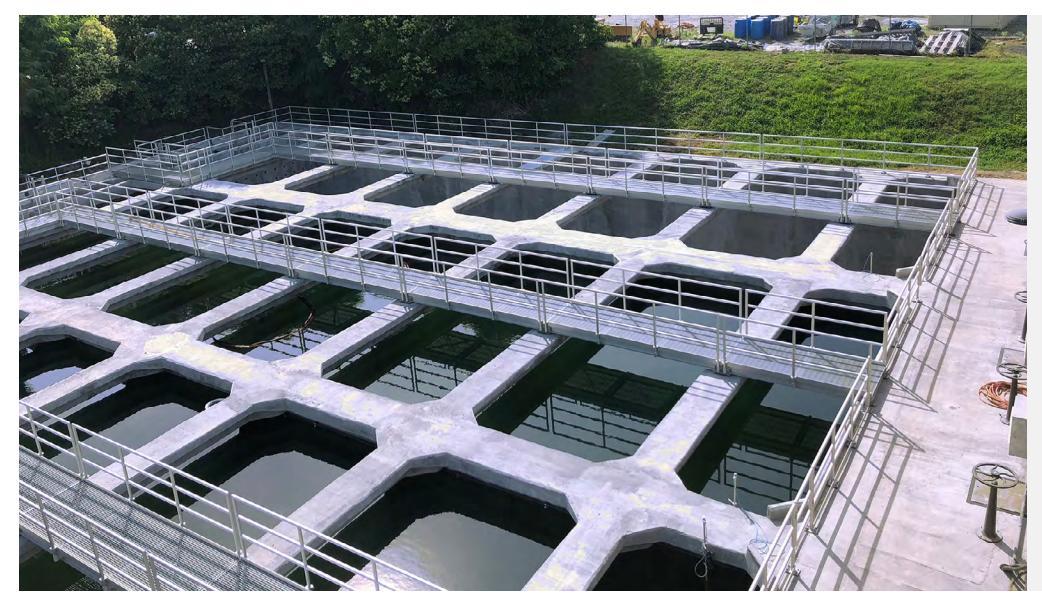
Fig 1 -- Xypex Megamix II was used to repair and protect the flocculation and sedimentation basins at the Mitchell Water Treatment Plant in Greensboro, North Carolina, USA. The cost to repair the structures is estimated to be 5-10 times less than the cost to rebuild and is expected to provide up to 40 years of additional service life.

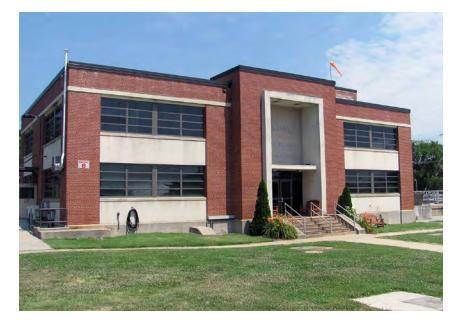
Fig 2 -- The Mitchell WTP is located in central Greensboro and provides up to 24 million gallons per day of potable water. The filter house (shown here) was renovated in 2017, including new concrete slab floors, some steel beams, and certain equipment.

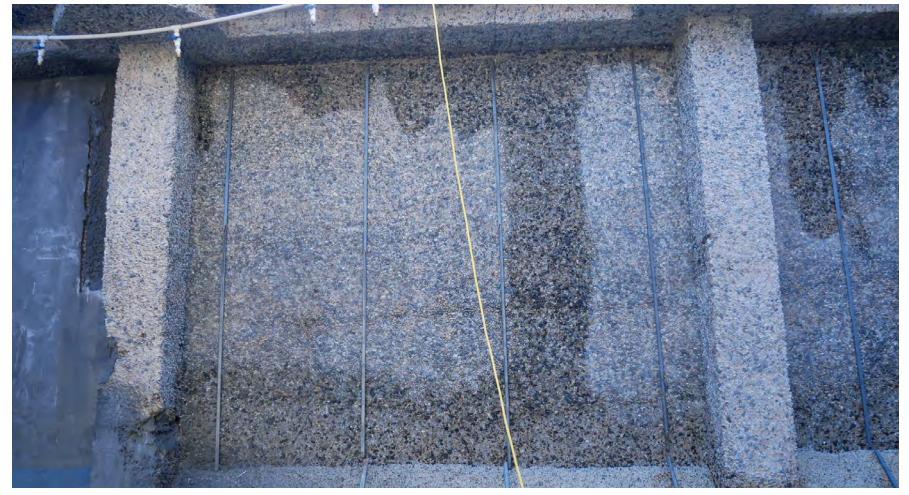
Fig 3 -- Exposed aggregate and missing chunks of concrete are the result of more than 60 years of concrete paste erosion due to exposure to water containing harsh chemicals and fine abrasives. Xypex Megamix II repair mortar was used to resurface and repair more than two acres of basins.

According to project engineers SKA Consulting Engineers Inc., based in Greensboro, many of Mitchell's concrete structures, indoors and out, were badly deteriorated having been built before modern concrete standards had been widely adopted. For instance, a lack of air entrainment, abrasion, and the attack of various chemicals over many decades had resulted in serious damage.

Chemicals such as ferric sulfate, Lime slurry, sodium hypochlorite, and deicing chemicals had taken their toll on the more than 60-yearold structure (fig 3). "Pretty much all of the concrete paste was missing from the surfaces of the flocculation and sedimentation basins located outdoors," notes SKA project engineer David Keatts, PE. "Paste erosion and freeze thaw damage left nearly two acres of basins with exposed aggregate and some isolated large pieces missing."

Following the successful rehabilitation of the filter building in Phase 1, the city undertook restoration of the basins in Phase 2 (fig 4). Keatts explains, "We needed a repair mortar to not only replace the missing concrete paste and cover the aggregate, but also provide waterproofing, vapor permeability, chemical protection, low shrinkage, freeze/thaw protection and it we had to be able to be spray applied."

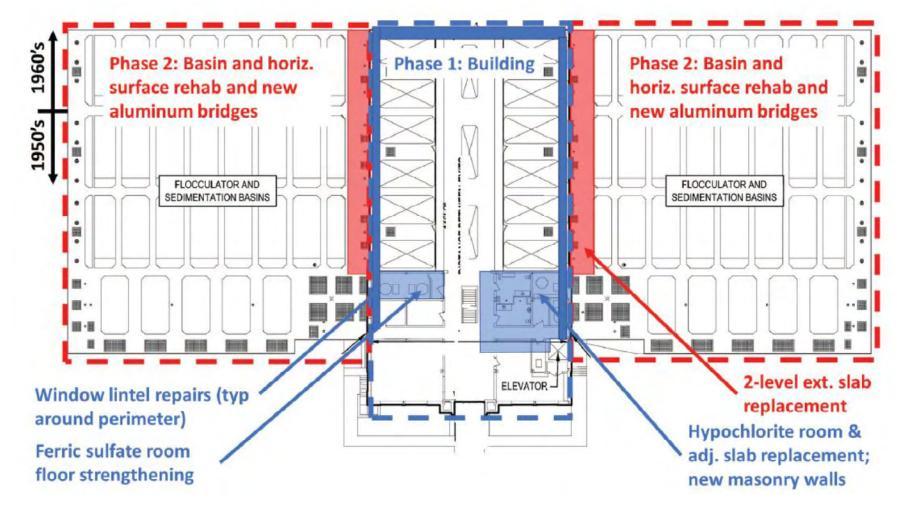
Fig 4 -- The City of Greensboro, N.C., USA invested more than \$14 million to rebuild the main structures at the Mitchell Water Treatment Plant. The work on the filter house and flocculation / sedimentation basins (shown here) had to be conducted in the winter months during lower water demand. Each section of basins could function independently, which allowed one side to be shut down but not impact water production.

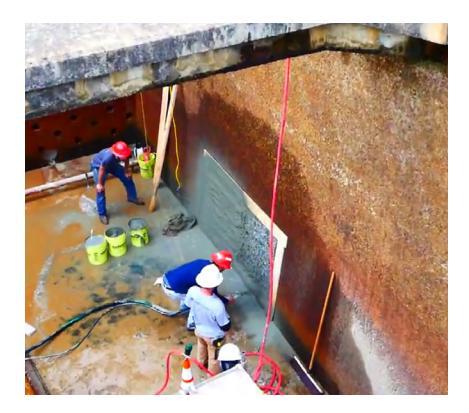
Fig 5 -- Conducting early test of spray applied Xypex Megamix II in order to bond test later. Exposed aggregate within basins can be seen. Deteriorated concrete on overhead beams is also visible.

While SKA and the city considered several alternatives, the design group ultimately chose Megamix II repair mortar from Xypex due to its successful use in many water and wastewater treatment plants around the world, as well as excellent on-site bond test results and mockups (fig 5). It was also important that Megamix is certified to NSF/ANSI/CAN 61 for products that will come in contact with drinking water.

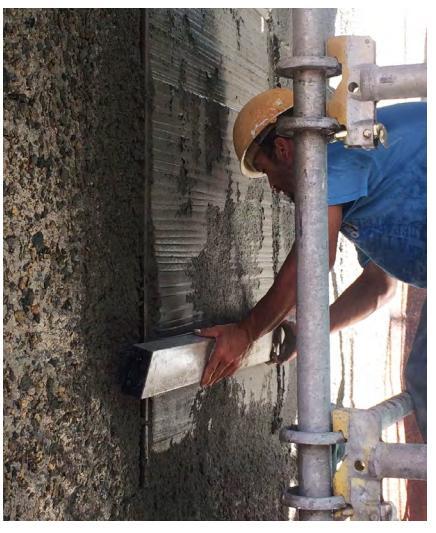
Fig 6 -- Skilled applicators used lightweight magnesium floats to smooth the Xypex Megamix II repair mortar once it has been spray applied. Light finishing was required in order to preserve the surface bond.

Xypex technical team. Paul Derby and George Arnold were very helpful in directing us on proper prep, application and finishing techniques. Megamix does not like to be over worked by the finishers, so that was a situation where Paul helped us understand how we could level it just enough and then finish it with a magnesium float (fig 6) to achieve the optimal surface without overworking it."

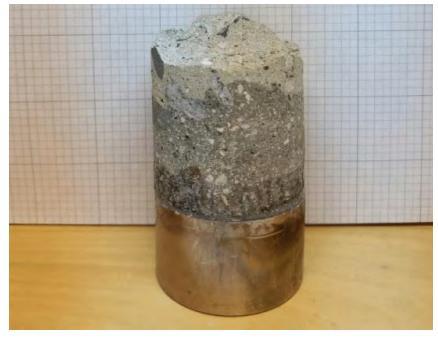
Fig 7 -- Extensive tests using vertical and horizontal mockups were conducted according to ASTM C1583 in order to ensure that the Xypex Megamix II repair mortar would provide sufficient bond with the substrate. This test core—one of two dozen—achieved 316 psi before breaking, well above the 200 psi target goal.

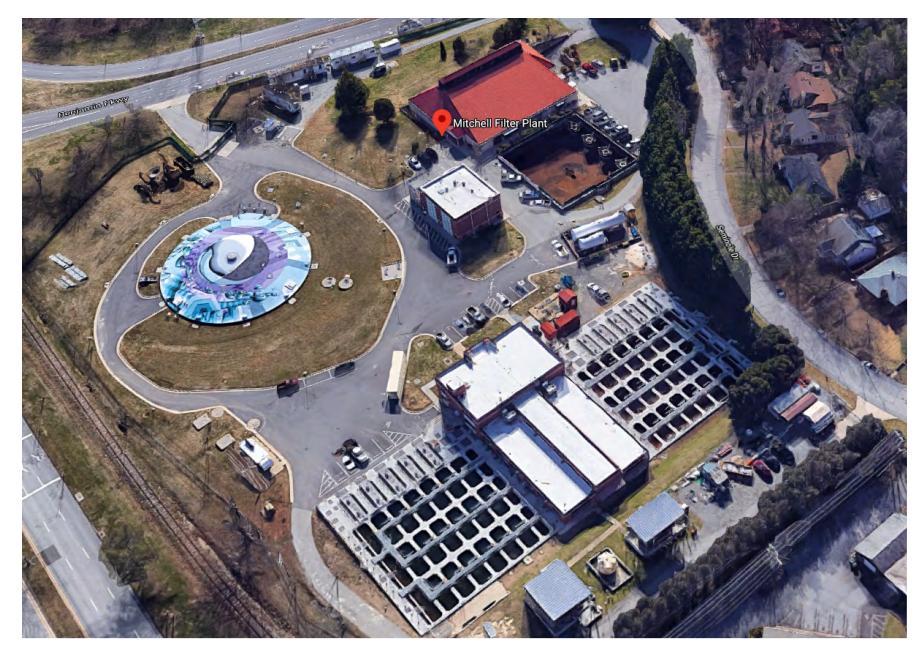
Fig 8 -- A key focus of the rehabilitation program were the filter house and adjoining banks of flocculation and sedimentation basins to either side. The new one million gallon clear well can be seen the upper left. It was recently painted by a world-renowned mural artist.

"Ultimately, the city chose to extend the life of the existing structures at the Mitchell plant," SKA's Keatts observes. It's estimated that the cost to rebuild the two acres of flocculation and sedimentation basins (fig 8) would have been 5-10 times the cost to repair and resurface them.

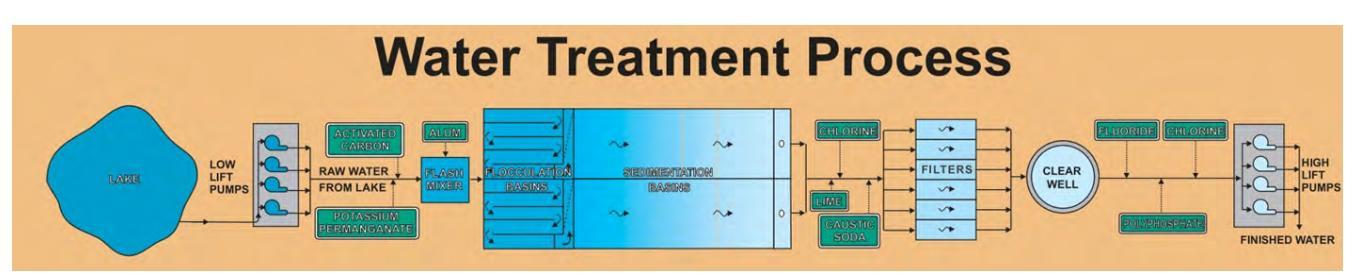
Fig 9 -- A simplified view of the water treatment process taking place at the Mitchell Water Treatment Plant in Greensboro. Chemicals detrimental to concrete are used in the process and caused significant damage to the structures over the decades.
