BIO-SAN® C500 Antimicrobial Crystalline Technology

For protection of concrete in severe sewage conditions

Antimicrobial Crystalline Technology for protection of concrete in severe sewage conditions.

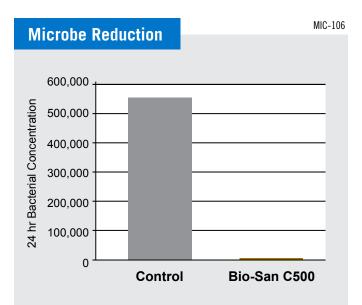
Independent testing showed that in concrete treated with Xypex Bio-San C500 the presence of the sewer bacteria Thiobacillus Novellus (Starkeya Novella) was substantially reduced.

TEST METHOD: Adapted method ISO 22196 determination of antibacterial resistance of concrete to Thiobacillus Novellus/Starkeya Novella.

1 Kills the acid-generating microbes present in sewage environments

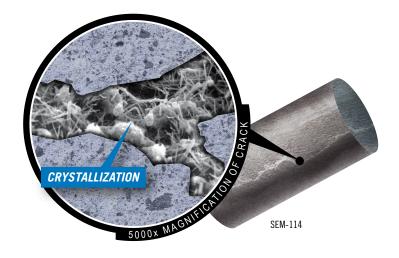
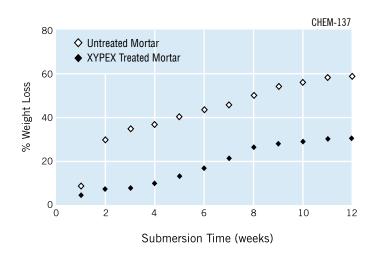
Concrete panels were cast and then cracked by force after which they were subjected to the ponding of water to measure the flow through the crack. After four days the 0.38 mm crack on the Xypex treated sample had stopped leaking completely. The 0.25 mm crack in the control sample continued to leak after 25 days.

4 Self-heals cracks up to 0.4 mm
