The World Standard in Concrete Waterproofing by Crystallization

**NO  
EQUAL™**

## XYPEX - THE CRYSTALLINE DIFFERENCE

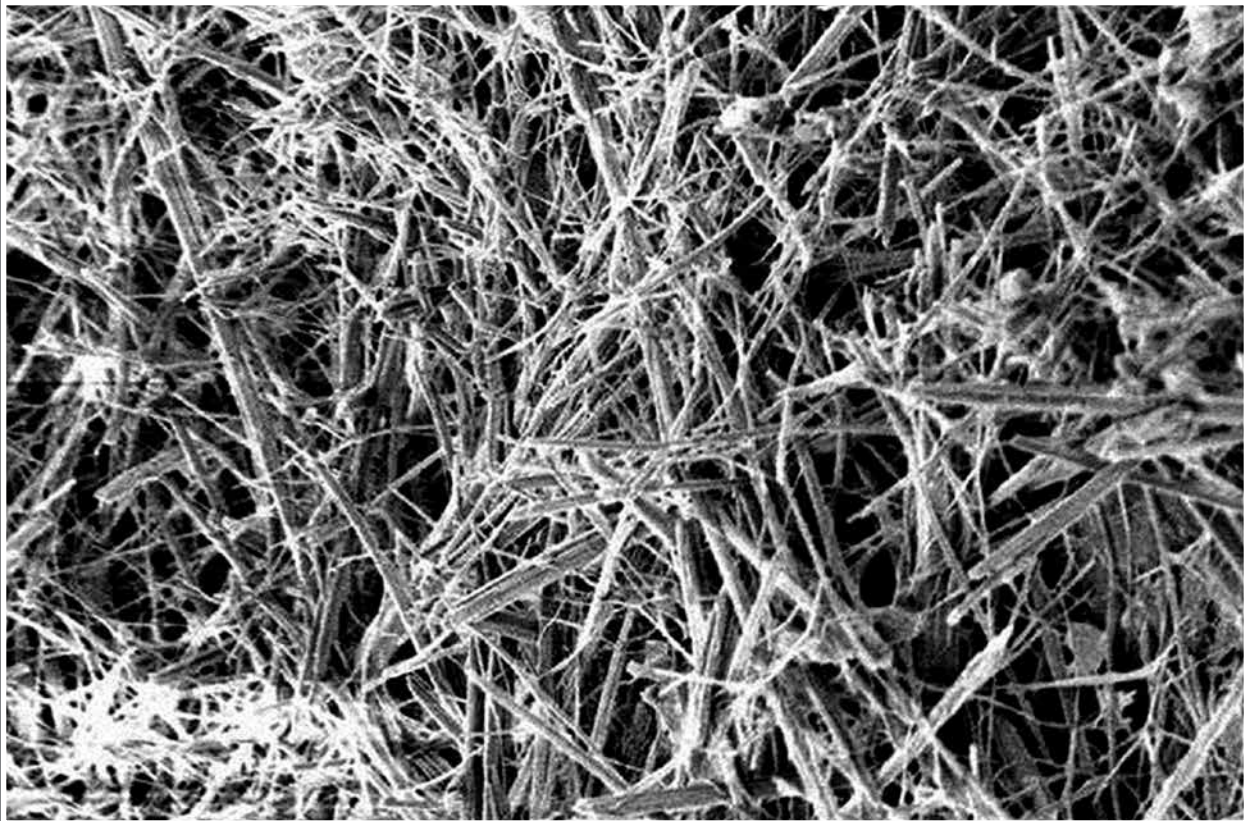
AUSINDUSTRY START GRADUATE PROGRAM  
SEM-105

As part of an extensive test program, samples were subject to water pressures equivalent to 100 m (330 ft.) of head. The 50 mm (2 in.) thick Xypex treated samples showed no signs of water penetration at this pressure, whereas the untreated control samples leaked even at 60 m (196 ft.) of water head. Below we see an SEM image of a Xypex treated sample at 2500x magnification. Note the dense mesh of Xypex crystals.

XYPEX TREATED CONCRETE

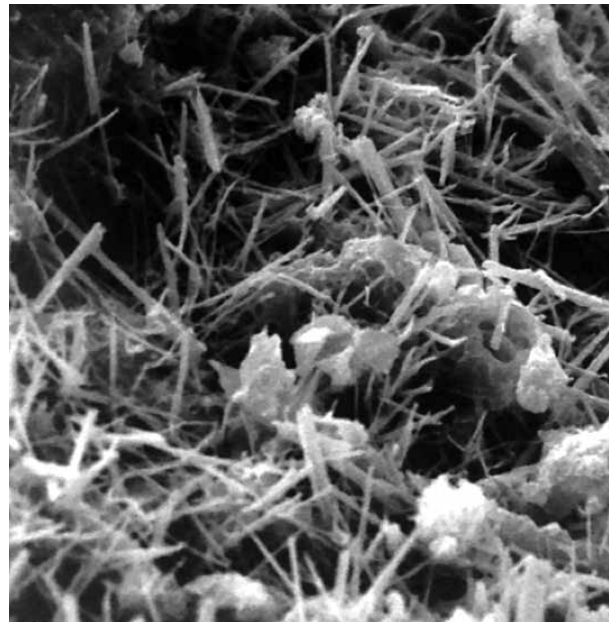
XAYABURI HYDROELECTRIC POWER PLANT, LAOS  
SEM-114

As part of the approval process, Xypex treated concrete was subjected to crack-healing testing. Concrete panels were cast, cracked by force and subjected to ponding of water over the cracks to measure the flow. The untreated control samples had cracks with an average width of 0.23 mm and continued to leak beyond the 25 day limit for the test. The Xypex treated panel had cracks with an average width of 0.38 mm and leakage through the cracks stopped after just four days. This was a site demonstration of the crack-healing abilities of Xypex and was subsequently captured in this SEM image.

XYPEX TREATED CONCRETE

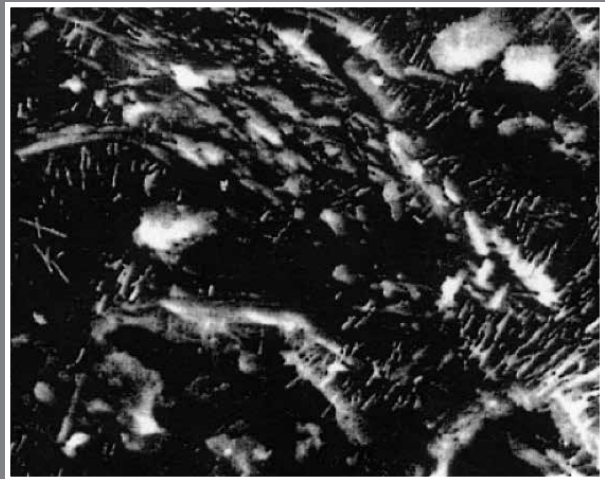
CIVIL ENGINEERING SOCIETY OF JAPAN  
SEM-100

Here, a sample of concrete coated with Xypex Concentrate on the negative side was left exposed to the environment for 12 months. SEM images were then taken of samples at different depths from the surface of the concrete. We can see evidence of crystalline growth at 300 mm (12 in.) from the surface of the concrete.

XYPEX TREATED CONCRETE

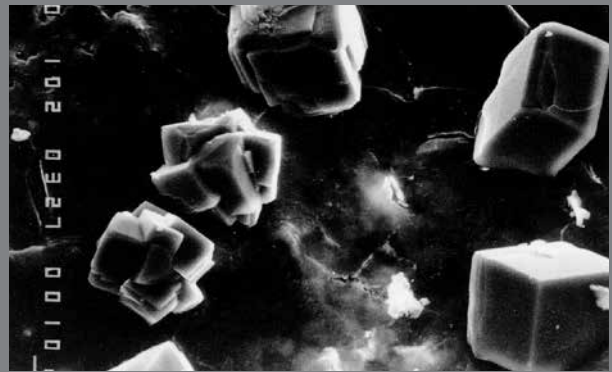
In the untreated image we can see precipitated calcium hydroxide particles and no crystalline growth. In the sample treated with Xypex Concentrate, we can see that at 50 mm (2 in.), an extensive crystalline formation has taken place, affording complete protection for the embedded reinforcing steel.

UNTREATED CONCRETE AT 50 MM

The essence of concrete durability is to protect the reinforcing steel of concrete from corrosion. Xypex achieves this by preventing the ingress of water and harmful chemicals. To assess the impact of Xypex on durability, investigators compared an untreated sample of concrete and a sample coated with Xypex Concentrate at a depth of 50 mm (2 in.), representing the standard cover depth of concrete over reinforcing steel.

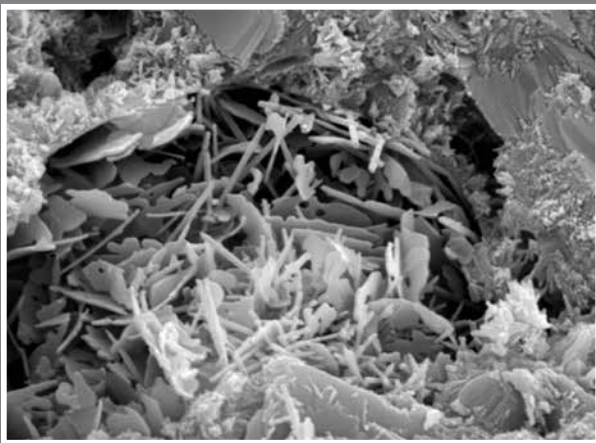
ELECTRICITY GENERATING AUTHORITY  
OF THAILAND, RATCHABURI POWER STATION  
SEM-113

XYPEX TREATED CONCRETE

The Ratchaburi Power Station is located on the estuary of the Mae Klong River and is exposed to destructive chloride attack. Xypex Concentrate and Modified were used to treat the 4-year-old roof decks of the cooling towers. Concrete cores extracted from the cooling towers were subjected to microscopic examination. In the SEM image taken at x7000 magnification and a depth of 20 mm, we see the developing crystalline formation interwoven with flat plate-like structures similar to calcium hydroxide. This formation protects the reinforcing steel from harmful effects of chloride attack.

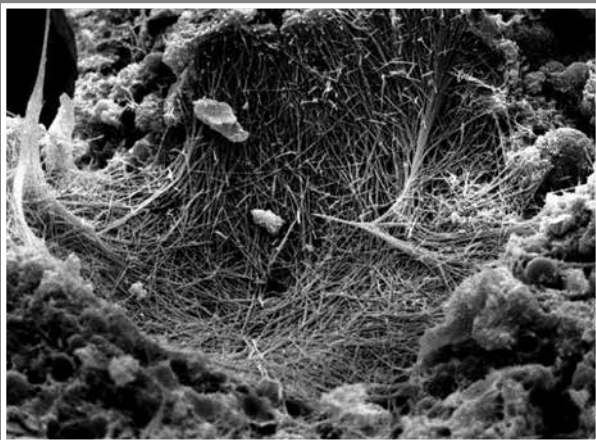
JINGHONG HYDROPOWER STATION,  
YUNNAN PROVINCE, CHINA  
SEM-115

XYPEX TREATED CONCRETE

In this image we can see the diverse mesh of the non-soluble crystalline structure that forms deep within the pores and capillary tracks of the concrete mass. Not only will the crystalline technology prevent the ingress of water into the concrete but will also protect the concrete from chemical attack. Whether from chlorides, sulfates, acids, hydrocarbons or industrial chemicals, Xypex will provide protection within a pH range of 3-11. Xypex has been proven both in independent laboratory tests and actual projects to extend the service life of concrete far beyond planned expectations.
