# Residential Basement Waterproofing Repair

## ABOUT THIS PROJECT:

**Location:**  
Arlington, Texas, USA

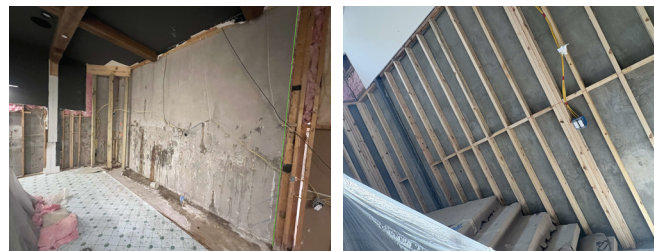
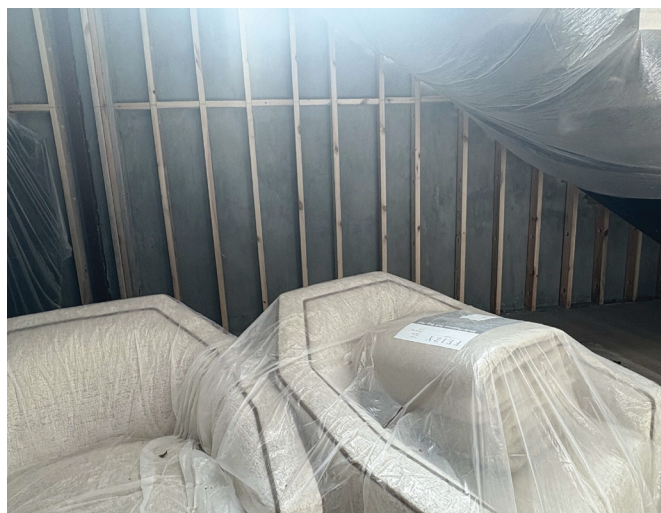
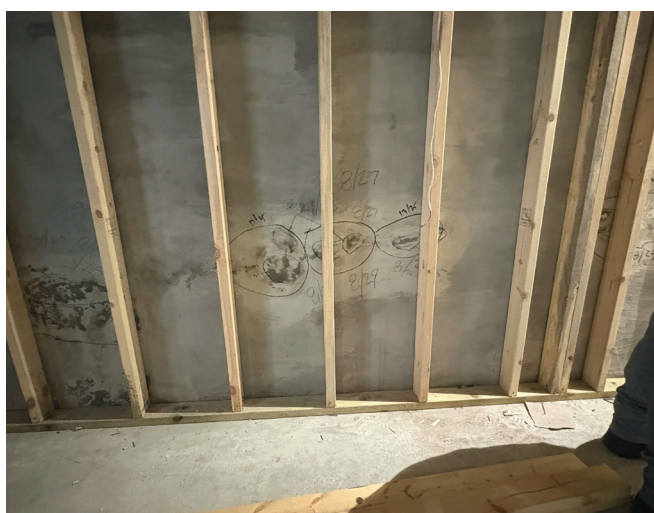
Months after completion, water leakage became visible through finished drywall, resulting in the removal of interior finishes and significant repair costs after the initial waterproofing methods failed to stop active leaks.

Progress was documented weekly during a heavy rainfall period by marking and dating leaking locations to demonstrate the advancement of crystallization. Within four weeks of application, all leaks were sealed and the basement achieved full watertight performance, providing the homeowner with a permanent repair solution without the need for membranes or reinjection.

The homeowner representative, contractor, and waterproofing company evaluated the conditions and developed a corrective waterproofing approach. The previous systems were removed, and defects were repaired using Xypex Patch'n Plug.

A Xypex crystalline coating system using Xypex Concentrate and Xypex Modified was then applied to approximately 1,100 square feet of basement wall surface.

The Xypex crystalline system penetrated the concrete substrate and reacted with moisture to form insoluble crystals that sealed water pathways and healed active leakage.
