## Anora Process Water Pool

**Market Segment:**  
Water Treatment Plant

**Location:**  
Koskenkorva rea,  
Finland

**Products Used:**  
Xypex Megamix II with  
Bio-San

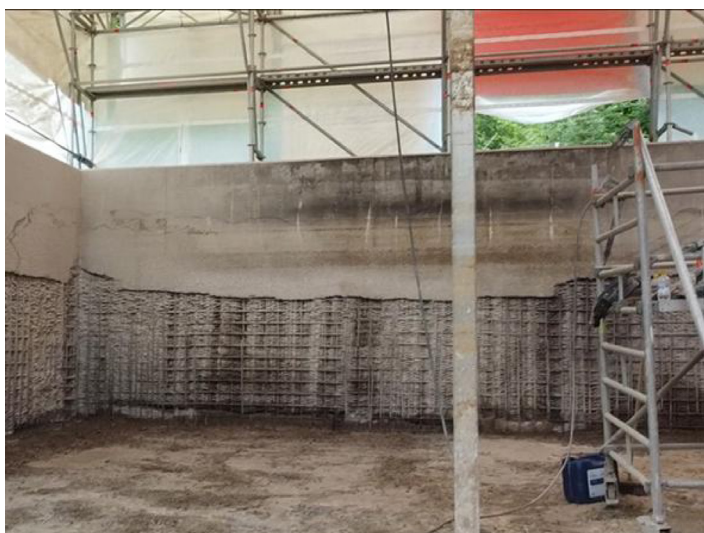
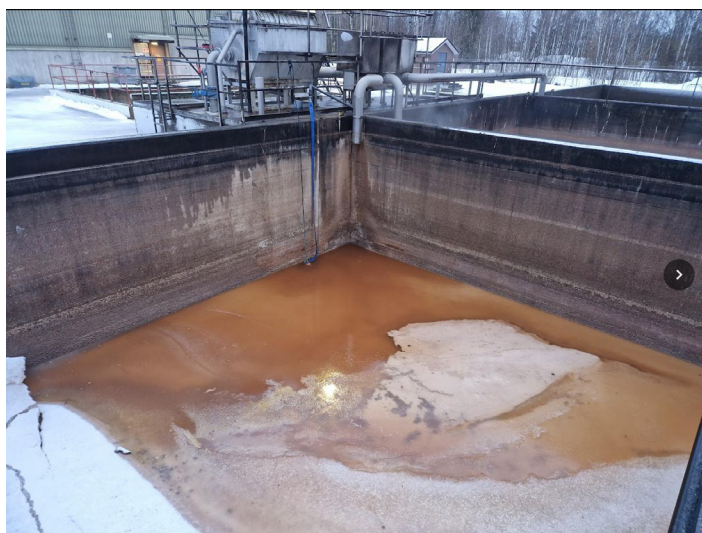
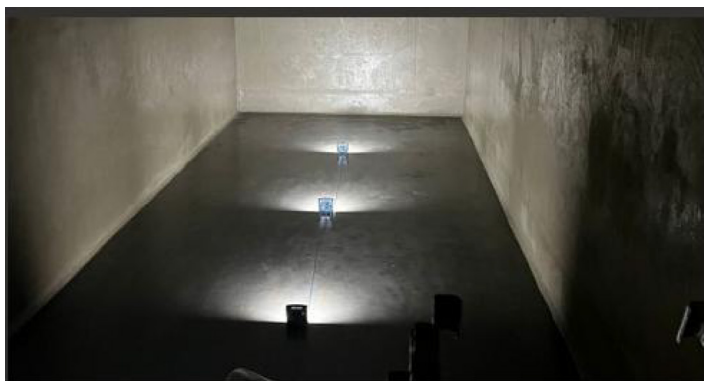
Three process water tanks were rehabilitated over three consecutive summer seasons, with one tank repaired each year. The deteriorated concrete structures were hydrodemolished to a depth exceeding 50 mm, ensuring exposure behind the reinforcing steel. Following this, the reinforcement was inspected and treated with appropriate corrosion protection.

Subsequently, the structures were rebuilt using sprayed concrete. An initial layer was applied to approximately 15 mm below the final surface level, followed by a finishing layer of approximately 15 mm using sprayed concrete with Megamix II with Biosan to achieve the required surface profile and durability.
