Swimming Pool

ABOUT THIS PROJECT:		
Market Segment: General Construction	Location: Kyiv, Ukraine	Products Used: Xypex Concentrate Xypex Patch'n Plug

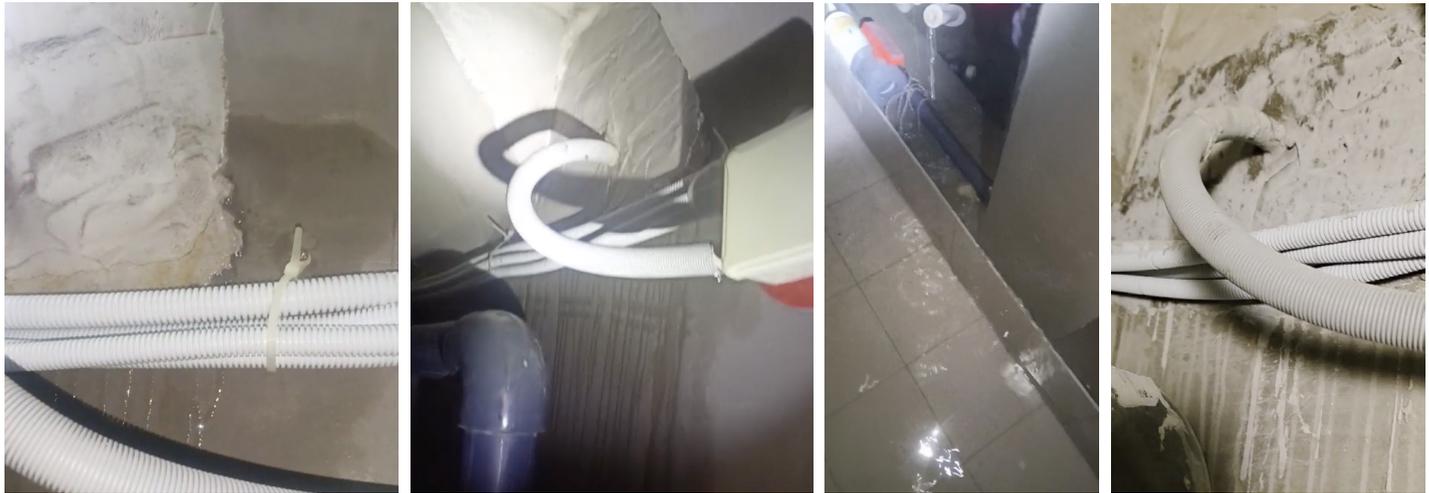
Active water leaks were identified within the concrete structures of the swimming pool technical room. Initial attempts to resolve the issue using injection methods proved ineffective and did not provide a durable solution. To address the problem, crystalline waterproofing materials Xypex Patch'n Plug and Xypex Concentrate were applied.

Xypex Patch'n Plug was used to immediately stop active leaks and seal cracks and construction joints, while Xypex Concentrate was applied to the concrete surfaces to create a continuous waterproofing barrier. As a result, the water leaks were eliminated, and the concrete structures were provided with reliable, long-term protection against water ingress.
