## Milner-Gooding Canal

Shoshone, Idaho, USA

Owner  
**BIG WOOD CANAL COMPANY  
OF SHOSHONE, IDAHO**

Products  
**MEGAMIX II, CONCENTRATE**

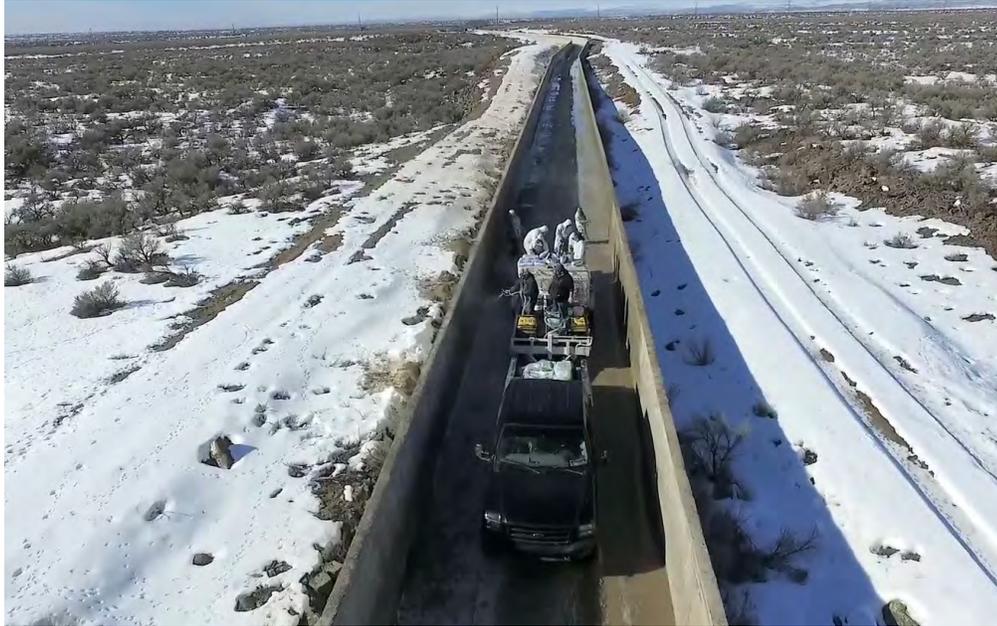
Since its construction in the 1930's, the Milner-Gooding Canal has provided vital water to the farmers in and around Shoshone, Idaho. Recently, a concrete flume on the canal which was showing extensive deterioration due to freeze-thaw attack has been restored with [Xypex crystalline waterproofing](#) materials.

The owner, Big Wood Canal Company of Shoshone, Idaho, hired MWH Global who, after thorough analysis determined the flume was still in sound structural condition and did not need replacement with a new structure. Instead, they chose Xypex crystalline waterproofing and repair products to restore and waterproof the existing structure to protect it against freeze that damage and extend its service life while saving millions of dollars in the process.

The first step in the restoration required extensive high pressure water blasting to remove the decades of lime deposits. Once these were removed and the surfaces were clean, Xypex [Megamix II](#) was used to patch badly deteriorated areas before a spray coat application of Xypex [Concentrate](#) at a coverage rate of 2 lb/sq. yd. (1 kg/m<sup>2</sup>). The application of Xypex products was completed by Guaranteed Waterproofing Company of Salt Lake, Utah in a continuous operation of watering, and coating all along the 2.2 mile long flume. A total surface area 375,000 sq. ft. (35,500 m<sup>2</sup>) was treated.
